A Review of the “Report on Mount Polley Tailings Storage Facility Breach, Independent Expert Engineering Investigation and Review Panel”

David M Chambers
Center for Science in Public Participation
February, 2015

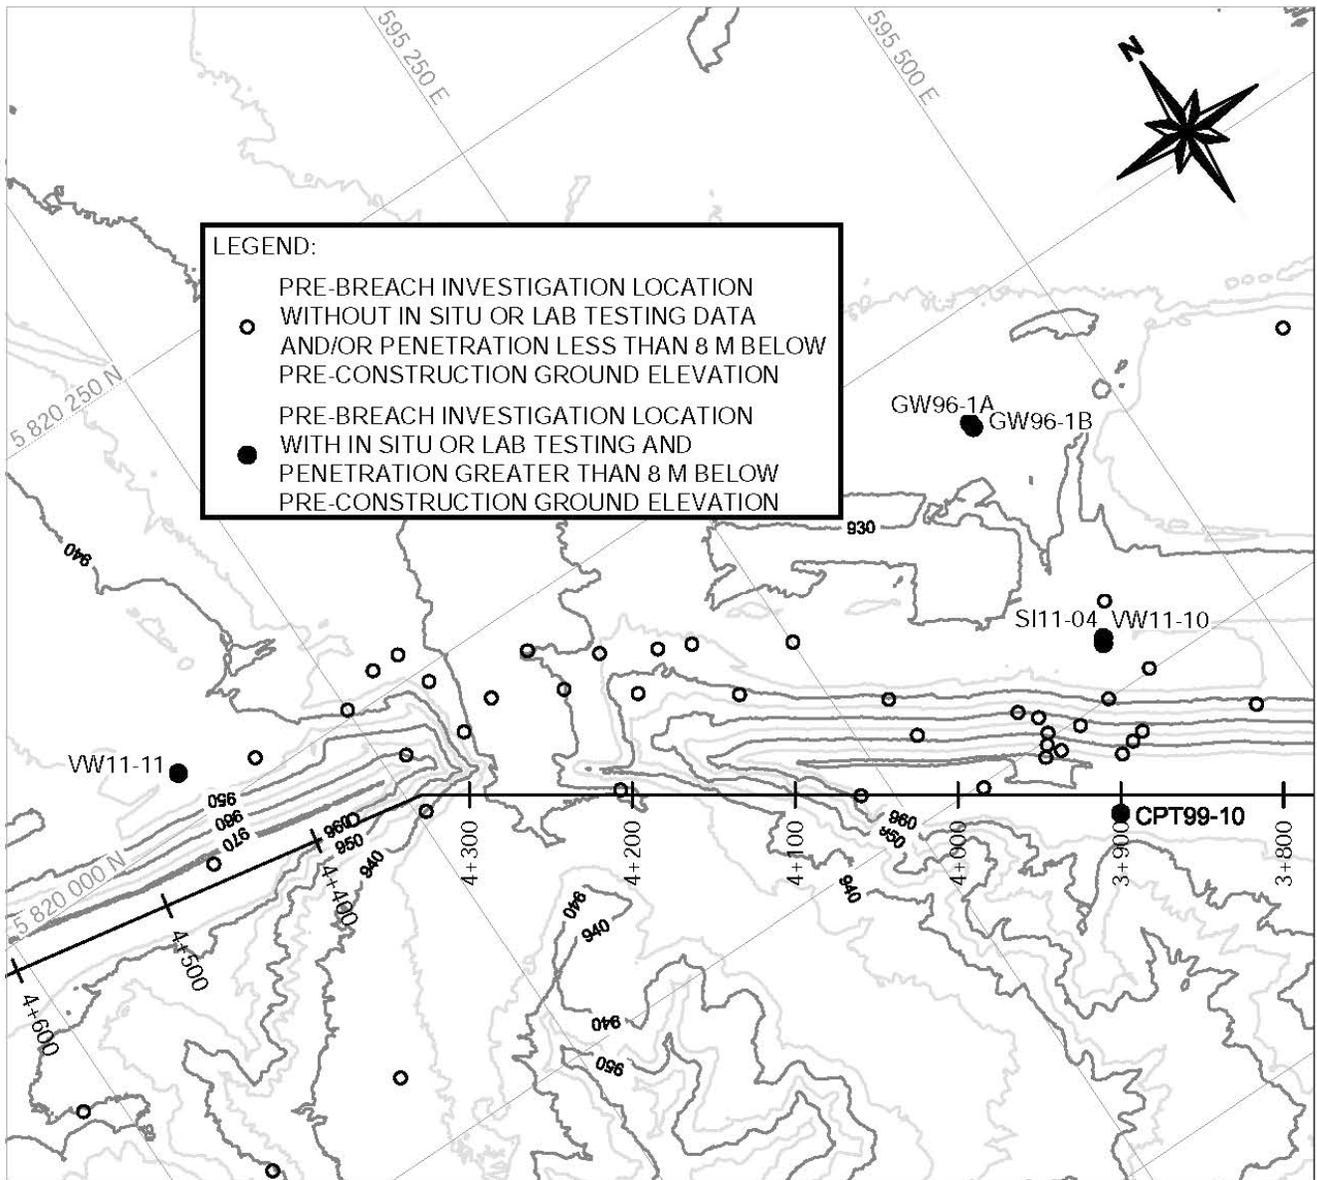
Figure 2: Pre-Failure Site Investigation Drillhole Locations in Breach Area

The drillholes depicted as solid circles in Figure 2 were drilled deep enough to intersect the Upper GLU, and clays intersected in those holes were lab tested for shear strength.

The drillholes depicted as open circles were not drilled deep enough to intersect the Upper GLU.

As can be seen in Figure 2, there are only shallow drillholes (open circles) in the area of the failed dam segment. There are no drillholes in the area of the dam failure that intersected the Upper GLU or that were lab tested for shear strength.

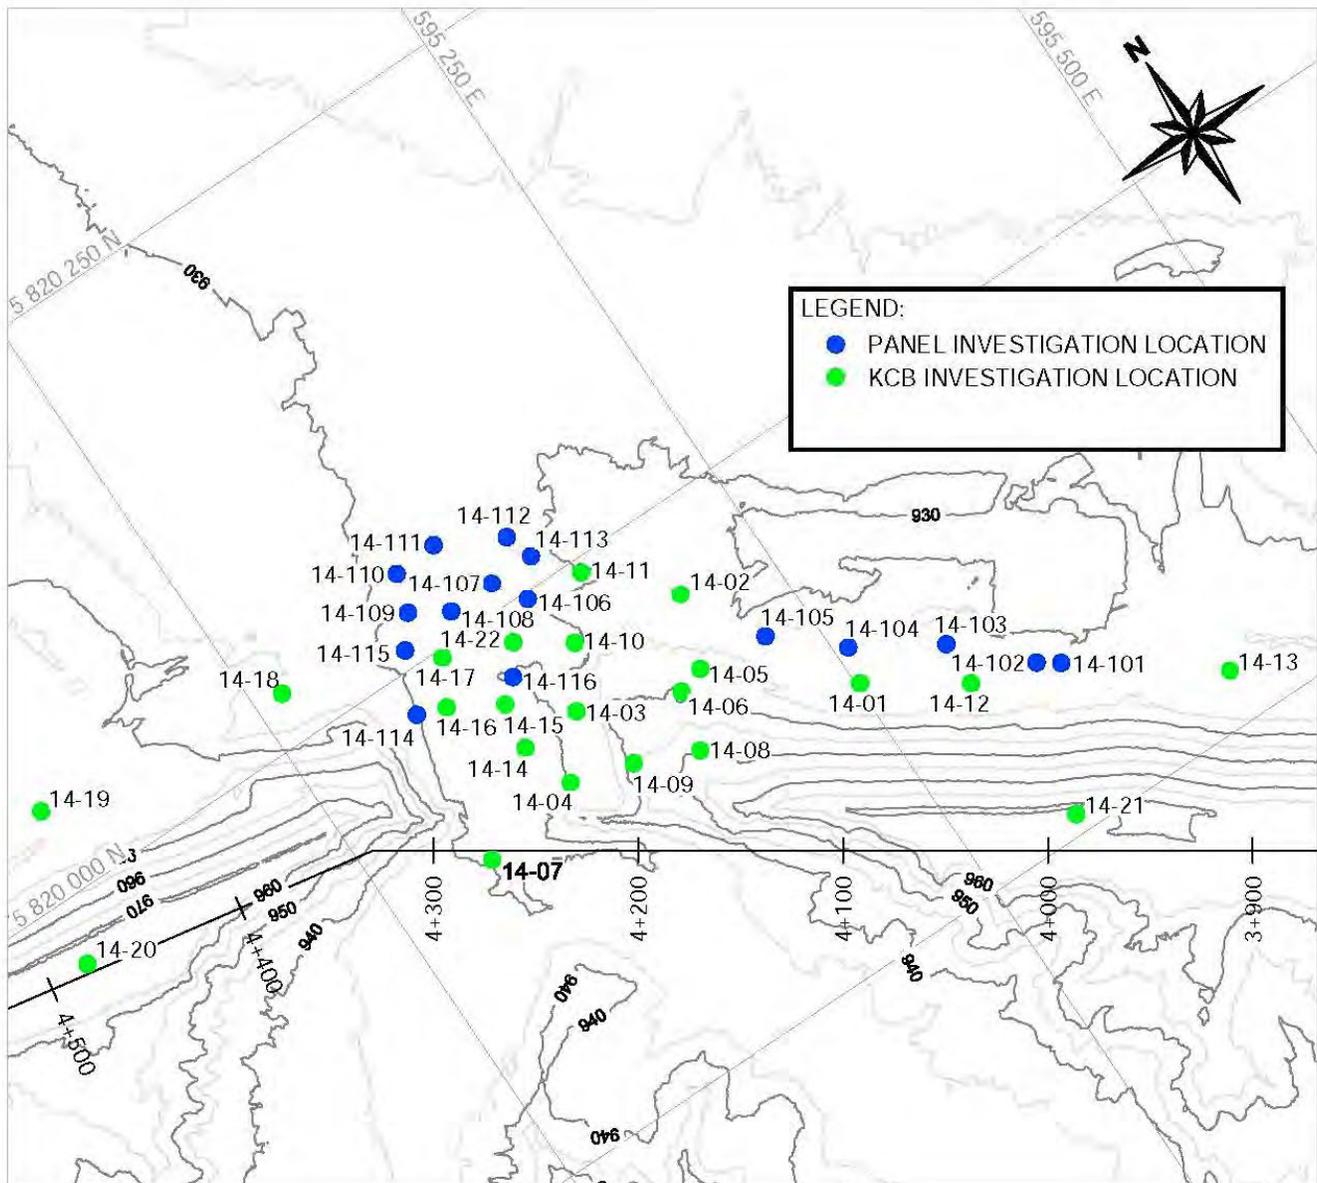
Figure 3: Joint and Panel Site Investigation Drillhole Locations

Post-failure drilling in the area of the failure, Figure 3, did intersect the Upper GLU, and lab testing of these clays clearly determined that the clay of the Upper GLU would fail under the increased pressures of the dam and tailings.

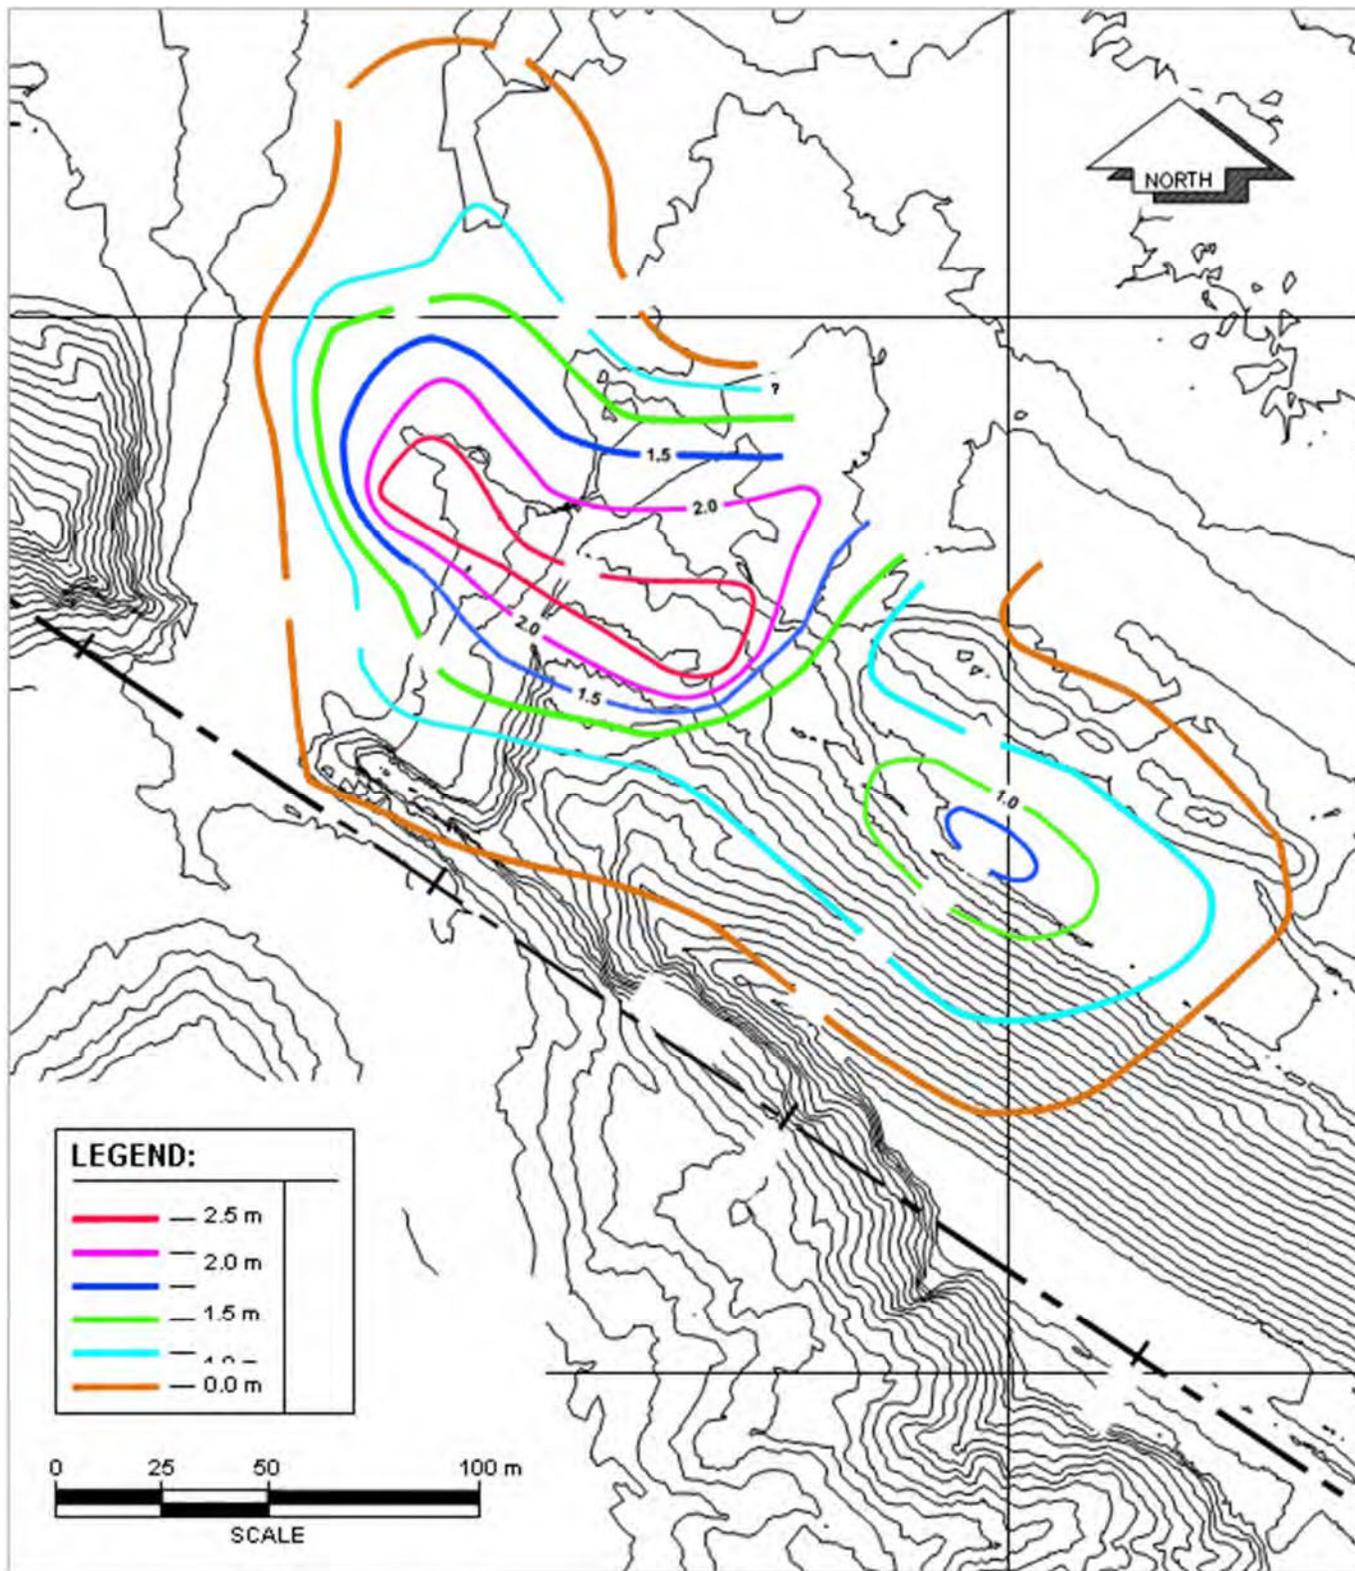
Figure 4: Contours of Upper GLU Thickness in Breach Area

Figure 4 shows the extent and thickness of the Upper GLU – just small enough to have avoided the original deeper drillholes – but large enough to cause the catastrophe.

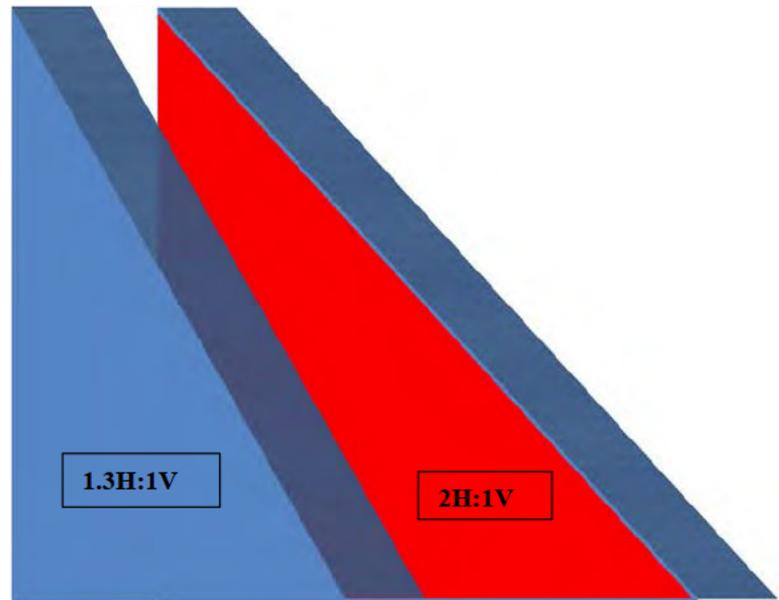
Figure 5: Tailings Dam Downstream Slopes

The specifics of the failure were triggered by the construction of the downstream rockfill zone at a steep slope of 1.3 horizontal to 1.0 vertical. Had the downstream slope in recent years been flattened to 2.0 horizontal to 1.0 vertical, as proposed in the original design, failure would have been avoided. The slope was on the way to being flattened to meet its ultimate design criteria at the time of the incident.

The plans for the dam originally called for a downstream slope of 2.0 horizontal to 1.0 vertical. Early on in the construction of the dam, which at the time of the failure had occurred in nine separately-approved construction events, a decision had been made to build the dam at a steeper slope (1.3 horizontal to 1.0 vertical) until enough construction rock became available to fill in the downstream “buttress” of the dam. The result was that that the steeper-sloped dam put more pressure on a smaller area, causing it to fail. As noted by the panel, if the dam had been constructed as designed, with a downstream slope of 2.0 horizontal to 1.0 vertical, the pressure from the dam and tailings would have been distributed over a greater area, and the dam would not have failed.

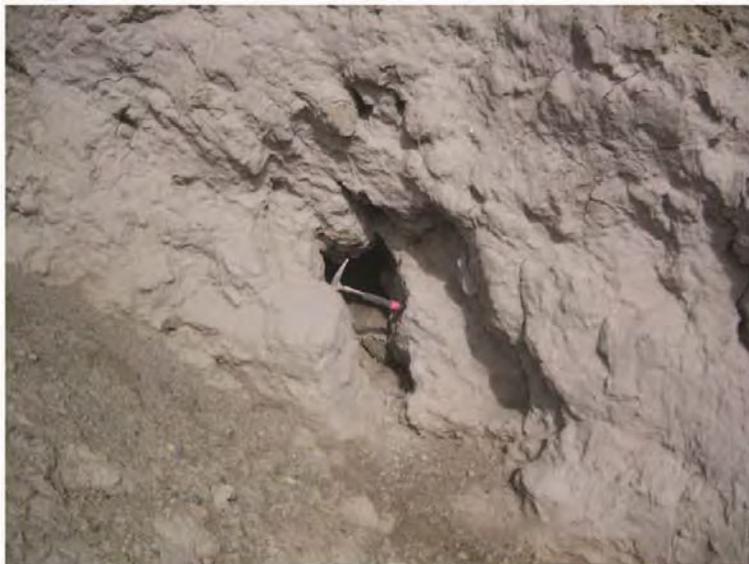
Figure 6: Void in left abutment (note geo-pick for size)

If the filter material is too coarse, it does not act as filter, but more like a drain. This can lead to voids in the core of the dam. This was essentially the cause of the Omai tailings dam failure. Had this situation been widespread it too could have led to dam failure at Mt Polley.

And, in fact, during the field work associated with the dam failure, a serious void was discovered (Figure 6), but there was no evidence of further voids discovered during the investigation. The quality control function of dam construction was obviously not working satisfactorily. This reflects poorly on both those who constructed the dam, those who were supervising the construction (this should have been an independent party), and on the standards set by regulators, which were not tight enough to detect these errors.
