**Modern Mine Study:  
Water Quality Performance and Predictions at U.S.  
Mines Permitted Since 1990**

**Prepared by Northeastern Minnesotans for Wilderness  
exclusively for Minnesota State regulatory agencies**

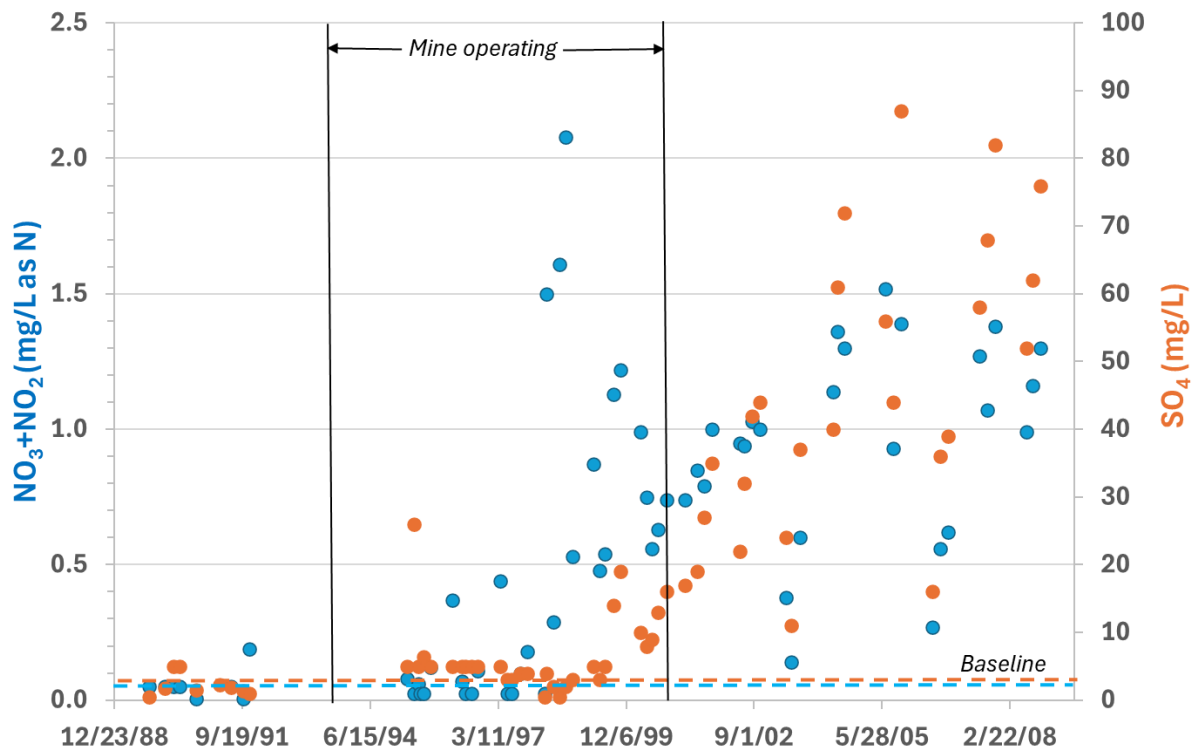
**Beartrack Mine.** Nitrate+nitrite and sulfate concentrations from 1989 to 2008 in Ward Gulch, WQ-4, downstream of the sedimentation pond dam and the South Pit, showing the dates of mine operation (1994-2000) and baseline values for the two constituents. (see the Beartrack Mine chapter for data sources)

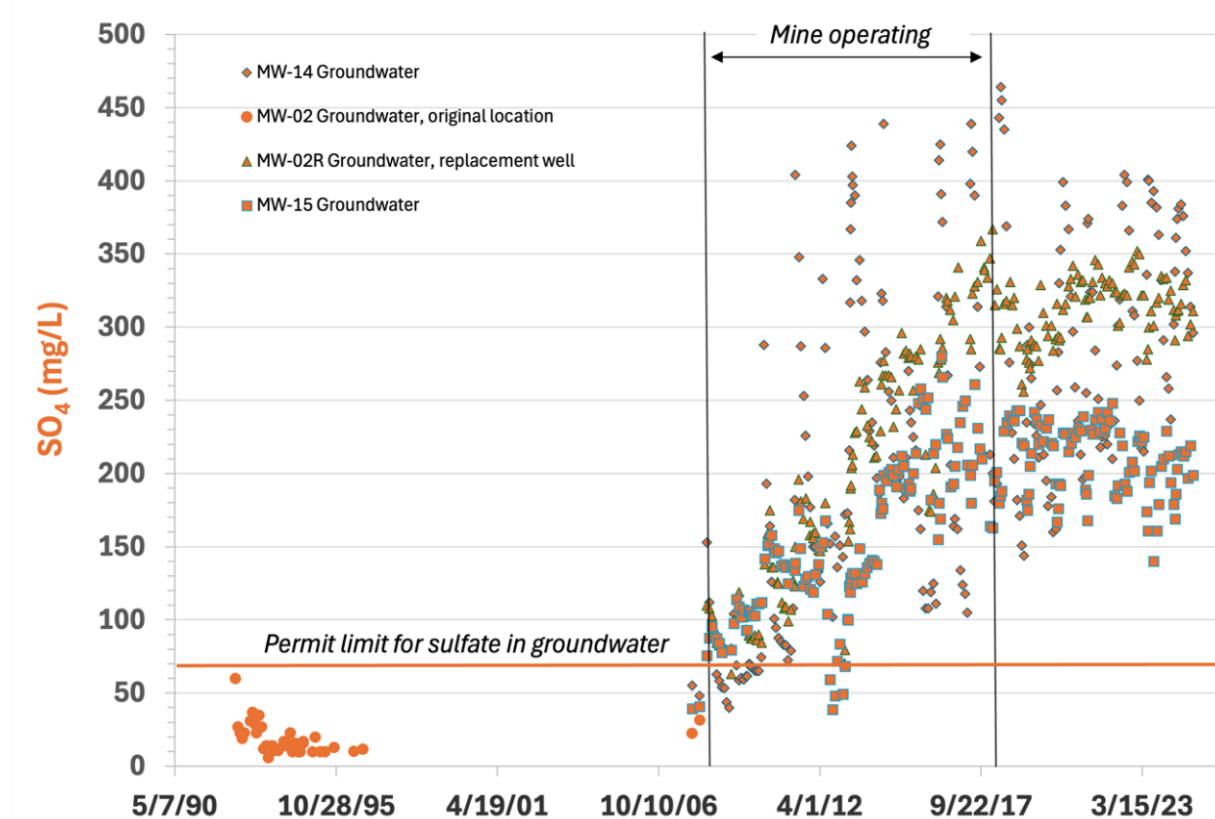
**Buckhorn Mine.** Groundwater in the NLF-3 Fault in MW14, MW2/2R, and MW15, outside the capture zone boundary, downgradient of the Gold Bowl Zone of the underground mine. The monthly average permit limit for sulfate is 69.5 mg/l. (see the Buckhorn Mine chapter for data sources)

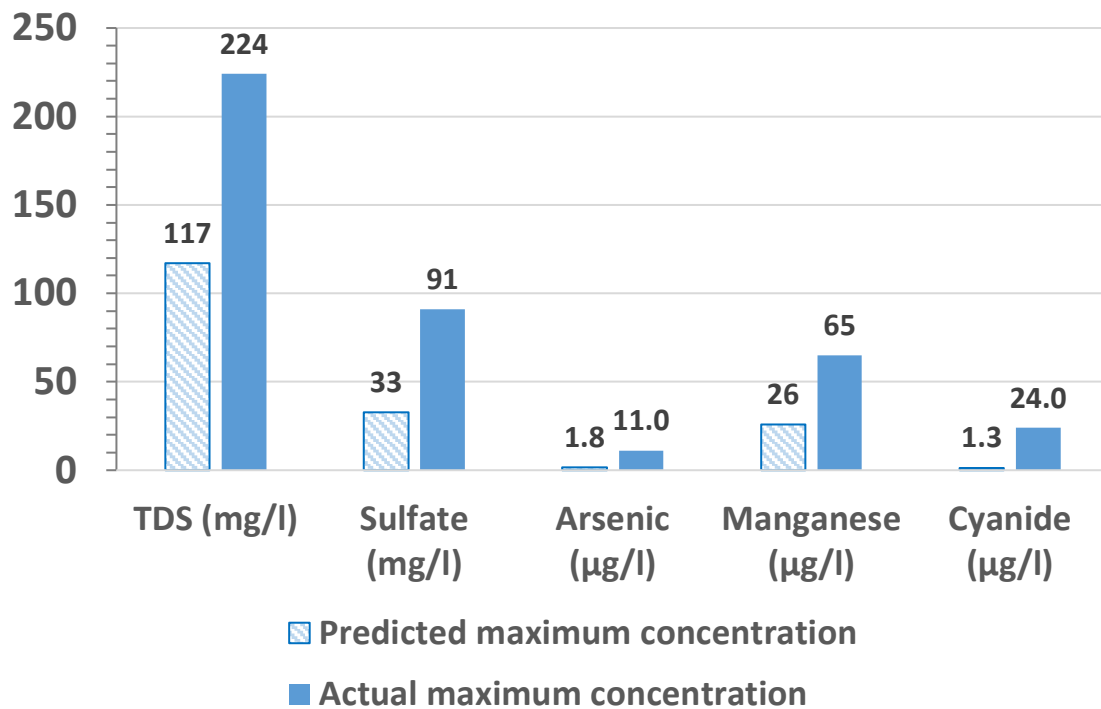
**Pogo Mine.** Predicted vs. Actual Maximum Concentrations in Treatment Plant Outfall 001.

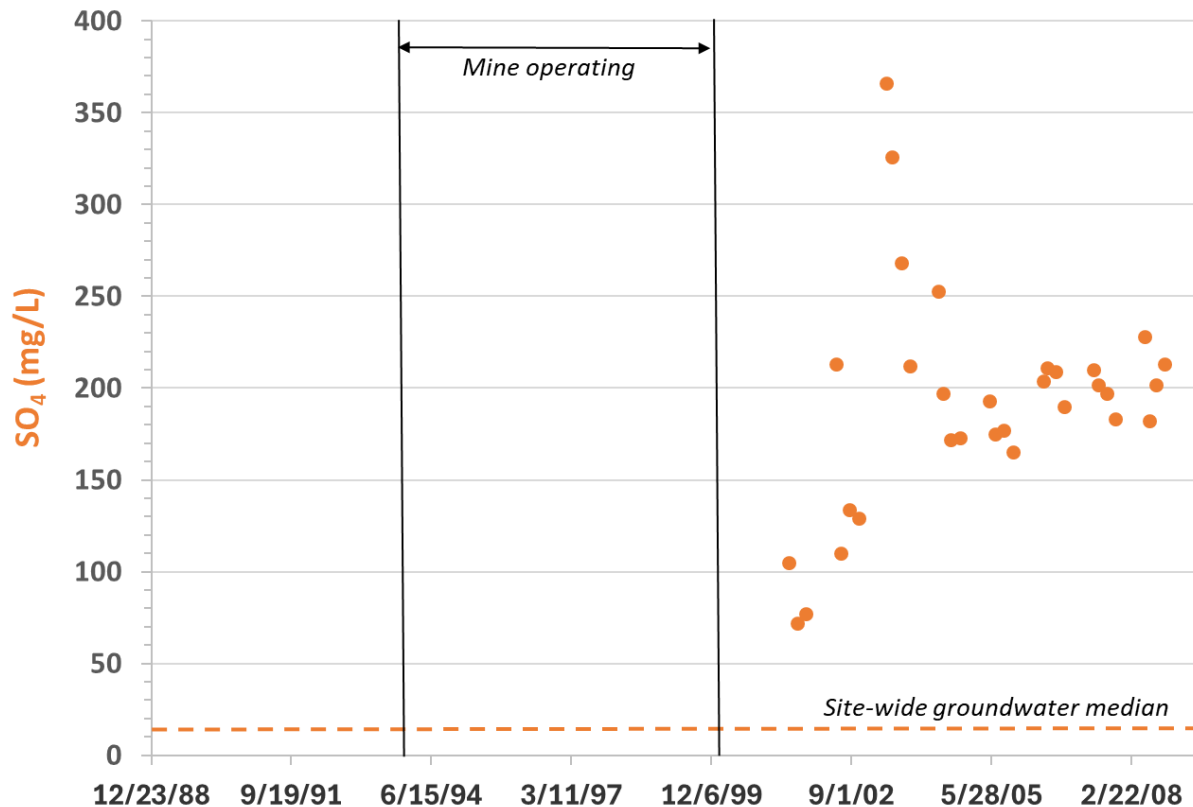
**Beartrack Figure 3. Sulfate concentrations in Ward's Gulch at WQ-31, downgradient of the waste rock pile, from 2001 to 2008.** Data sources: Site-wide groundwater median: FEIS. *Beartrack.FEIS.USDA 1991.pdf* [144-145]; Monitoring data: Meridian Beartrack Co., 2009. 2008 Annual Water Quality Report, Electronic Attachment WQ-31 Annual Graphs 2008. *Beartrack 2008 Data\Beartrack.WQ-31 2008 Data.xls*

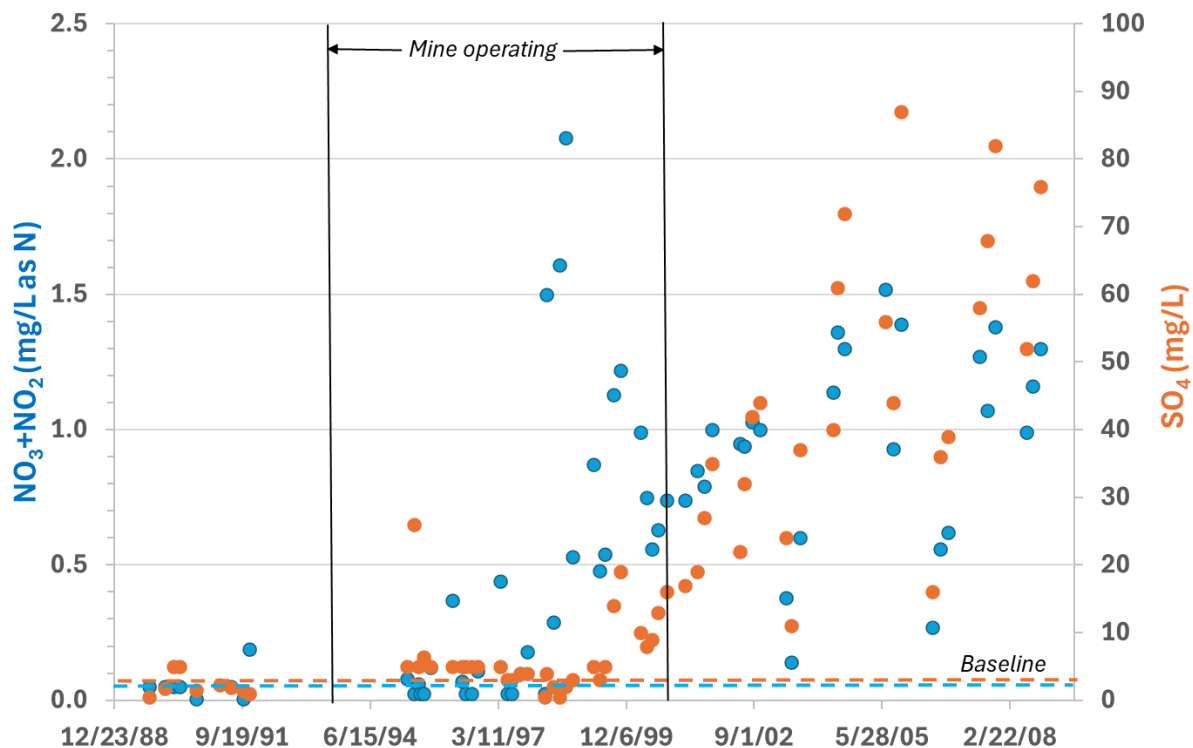
**Beartrack Figure 4. Nitrate+nitrite and sulfate concentrations from 1989 to 2008 in Ward Gulch, WQ-4, showing the dates of mine operation (1994-2000) and baseline values for the two constituents. Values below detection are plotted at one-half the quantitation limit.**

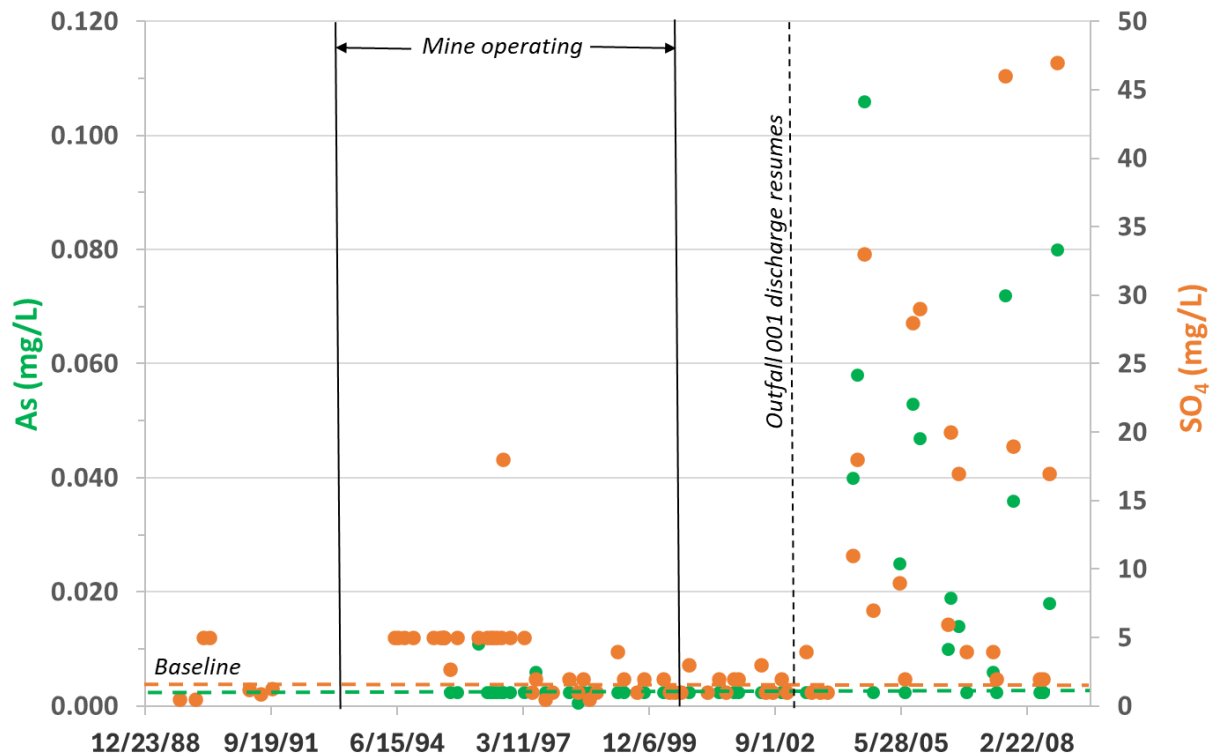
**Beartrack Figure 5. Arsenic and sulfate concentrations in Napias Creek at WQ-9, downstream of NPDES Outfall 001, 1989-2008 (sulfate) and 1995-2008 (arsenic).** No discharge occurred from June 2000 through October 2003, when water from all sources went to the South Pit for accelerated filling; Outfall 001 discharge resumed in November 2003. Note that the sulfate practical quantitation limit (PQL) varied between 1 and 10 mg/l throughout the period of record; the arsenic PQL was 0.005 mg/l. Values below detection are plotted at one-half the PQL. *Data Sources: FEIS. Beartrack.FEIS.USDA 1991.pdf*; Meridian Beartrack Co., 2009. 2008 Annual Water Quality Report, Electronic Attachment WQ-9 Annual Graphs 2008. *Beartrack 2008 Data\Beartrack.WQ-9 2008 Data.xls*

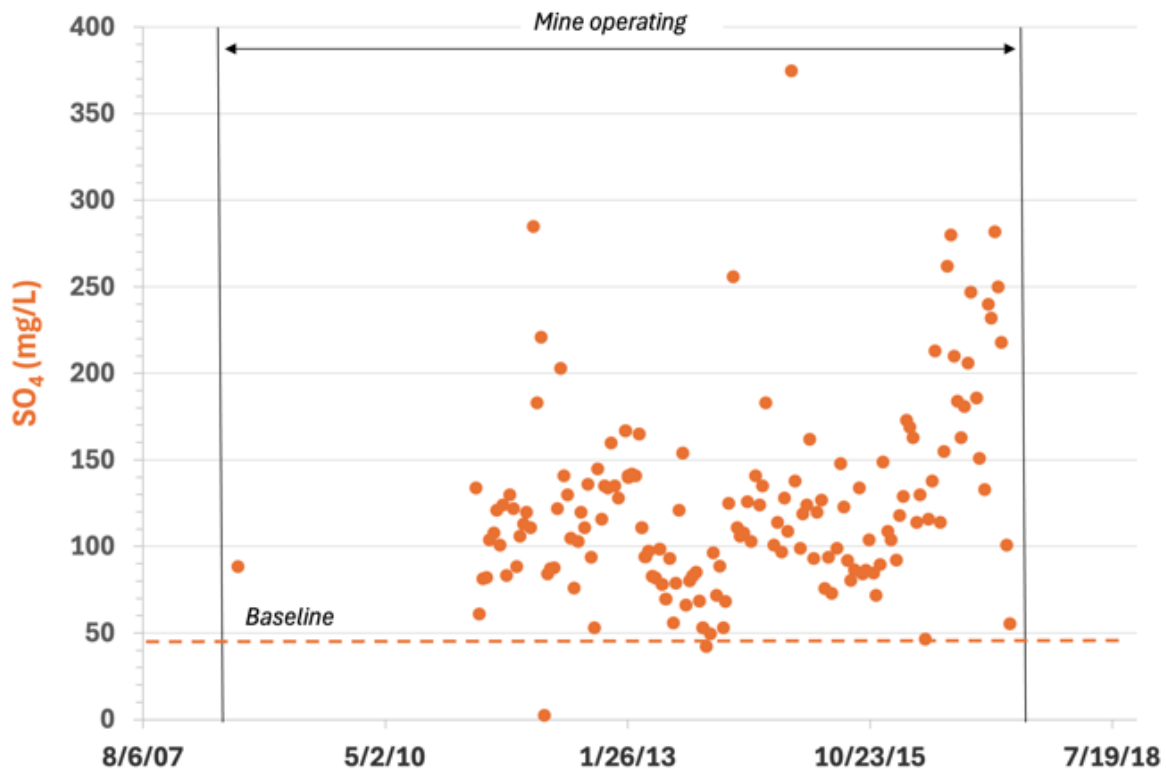
**Buckhorn Figure 2. Sulfate Concentrations in Gold Bowl Mine Sump, 2008-2017.**

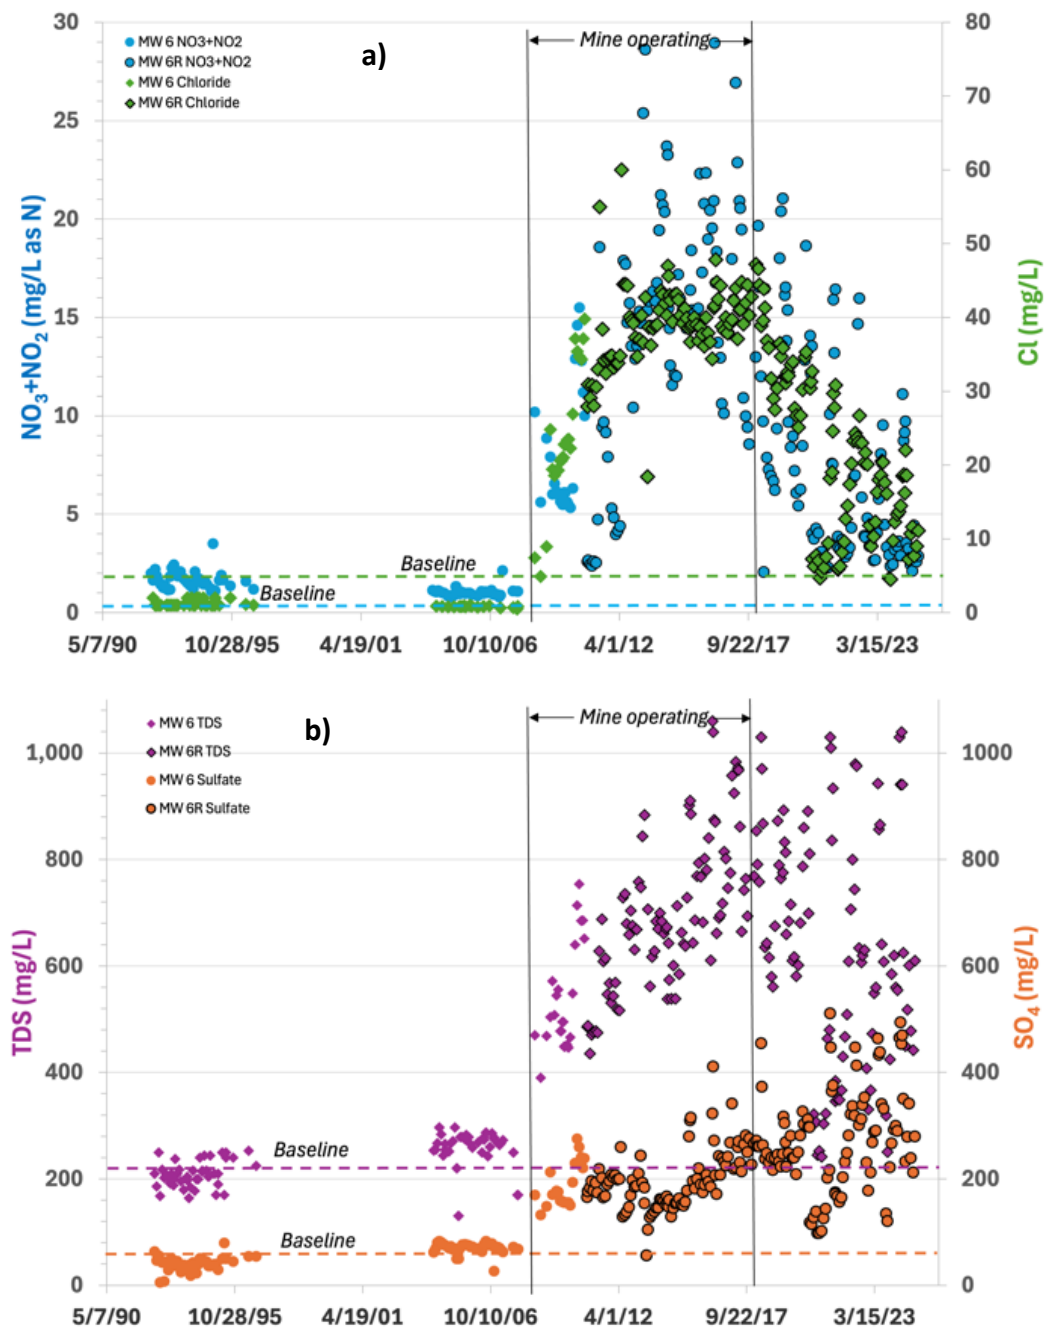
**Buckhorn Figure 5. Groundwater quality at MW6/6R, within the capture zone boundary, downgradient of the Gold Bowl Zone of the underground mine. a) nitrate+nitrite concentrations, b) TDS and sulfate concentrations.** Graphs created using data from database maintained by Okanogan Highlands Alliance.

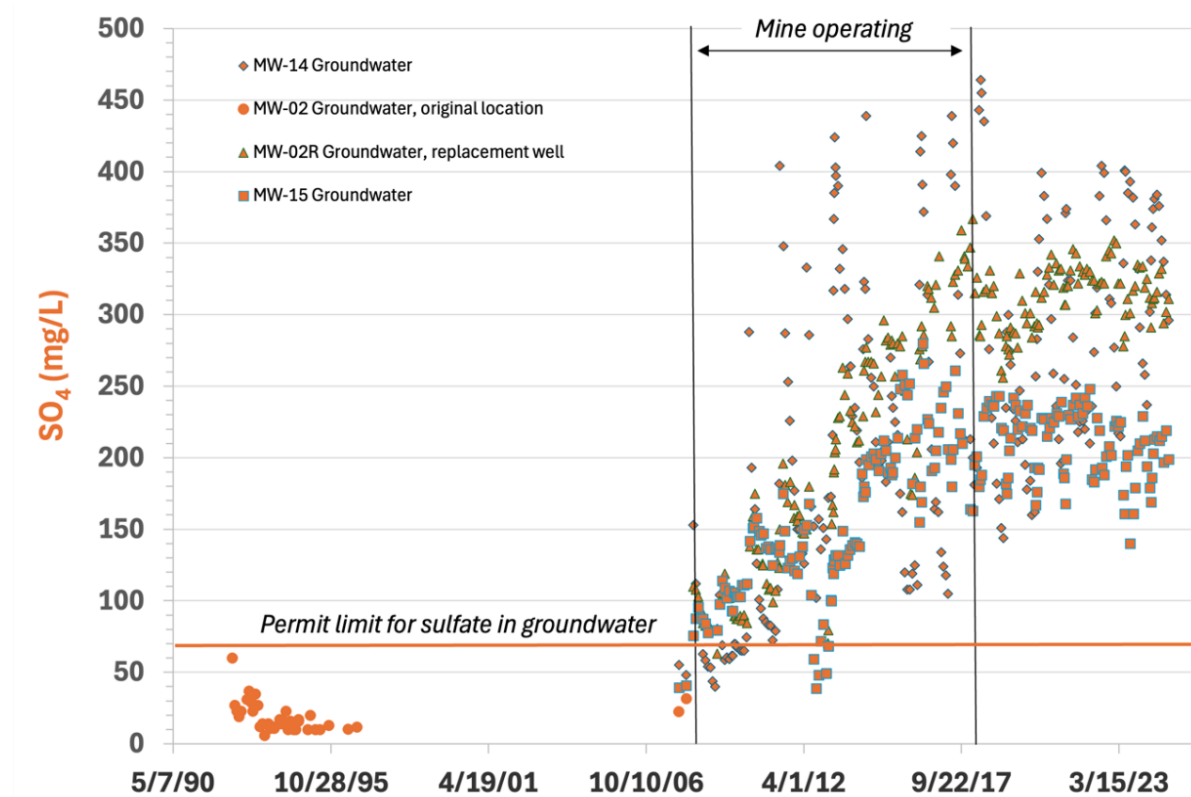
**Buckhorn Figure 6. Sulfate concentrations in the NLF-3 Fault in monitoring wells MW14, MW2/2R, and MW15, outside the capture zone boundary, downgradient of the Gold Bowl Zone in the underground mine. Monthly average permit limit for sulfate is 69.5 mg/l. Graphs created using data from database maintained by Okanogan Highlands Alliance.**

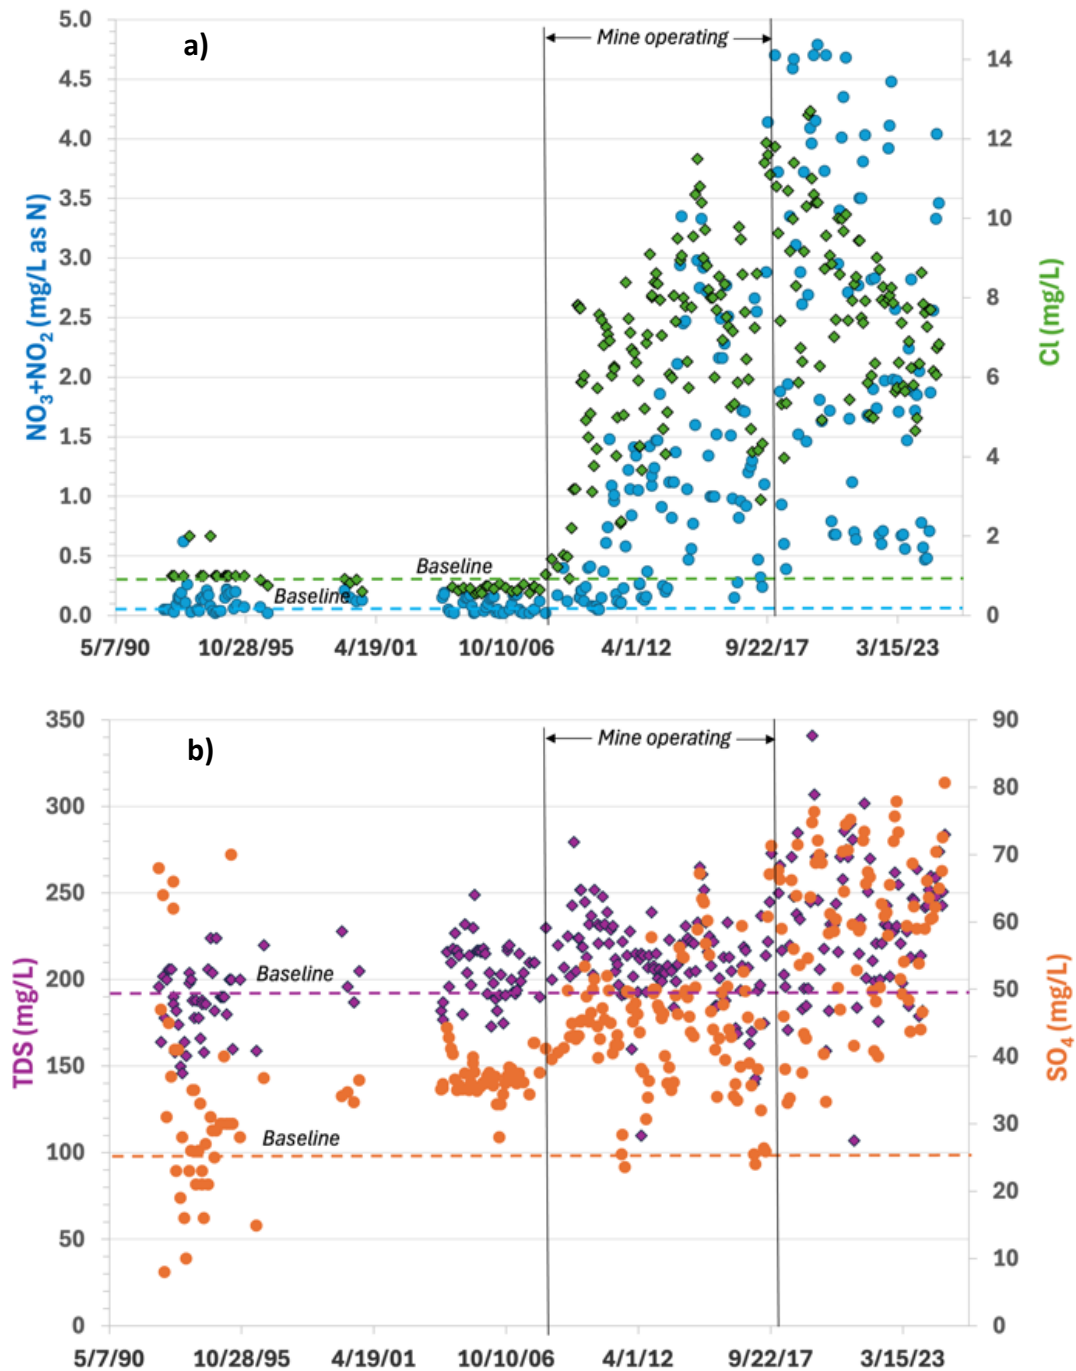
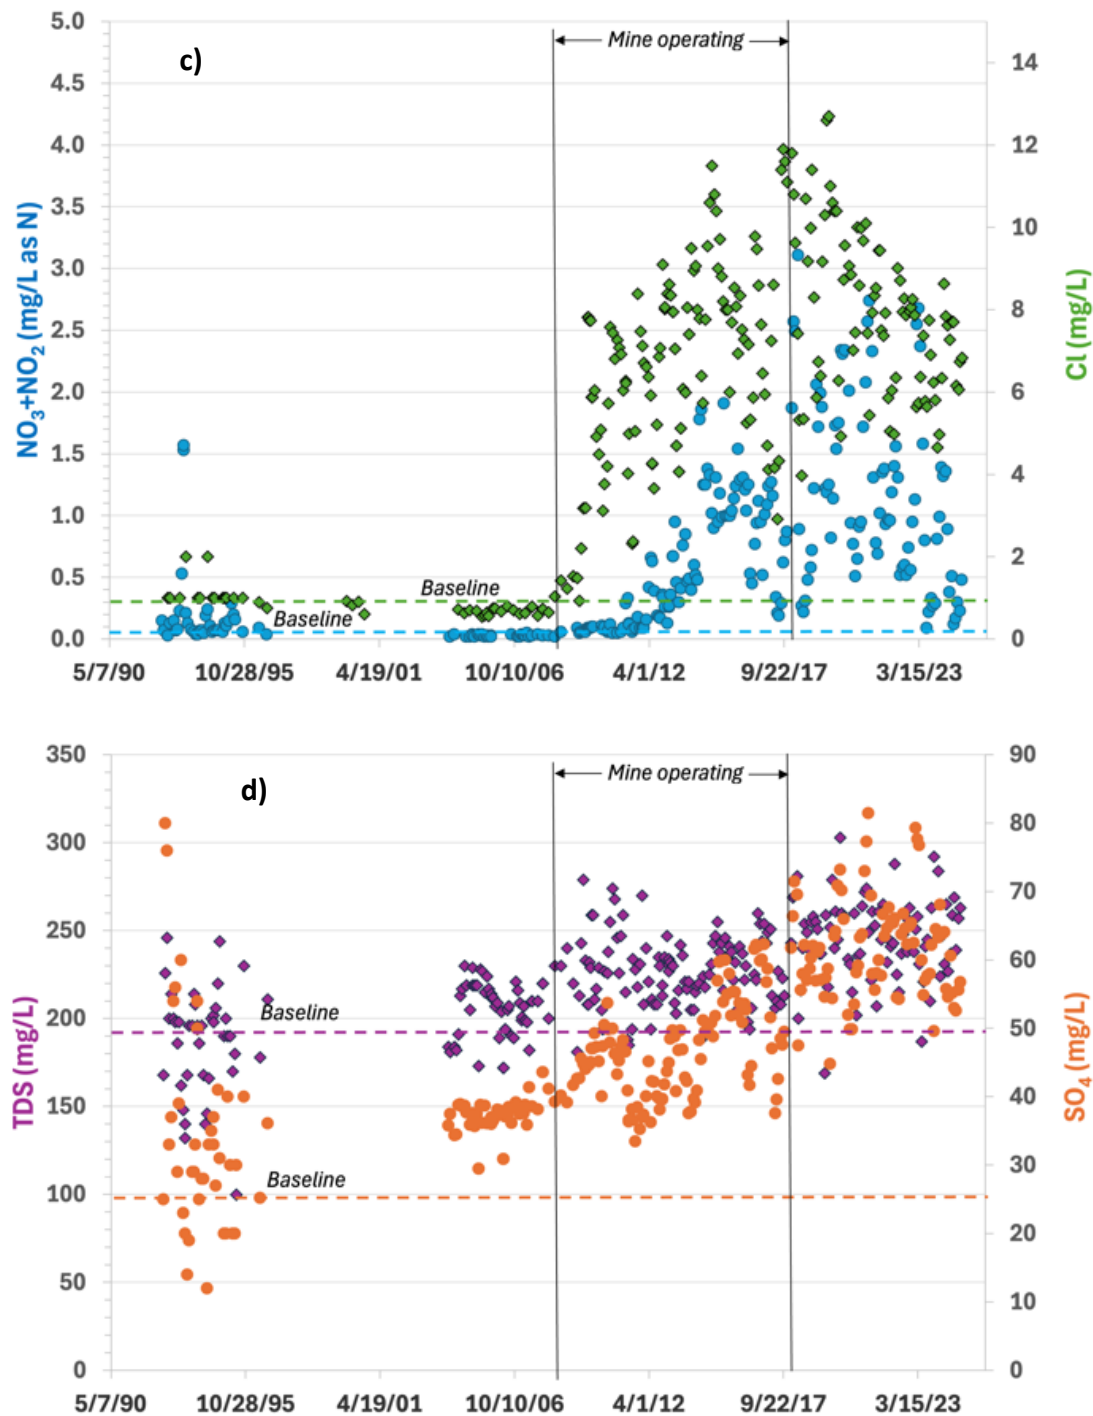
**Buckhorn Figure 7. Groundwater quality in monitoring wells MW7: a) nitrate+nitrite and chloride; b) TDS and sulfate and MW9: c) nitrate+nitrite and chloride; d) TDS and sulfate.** Both wells are located ~1,500 ft downgradient of the groundwater capture zone boundary. Monthly average permit limits: chloride 2 mg/l, nitrate 1.33 mg/l, sulfate 69.5 mg/l, TDS 290 mg/l. Graphs created using data from database maintained by Okanogan Highlands Alliance.

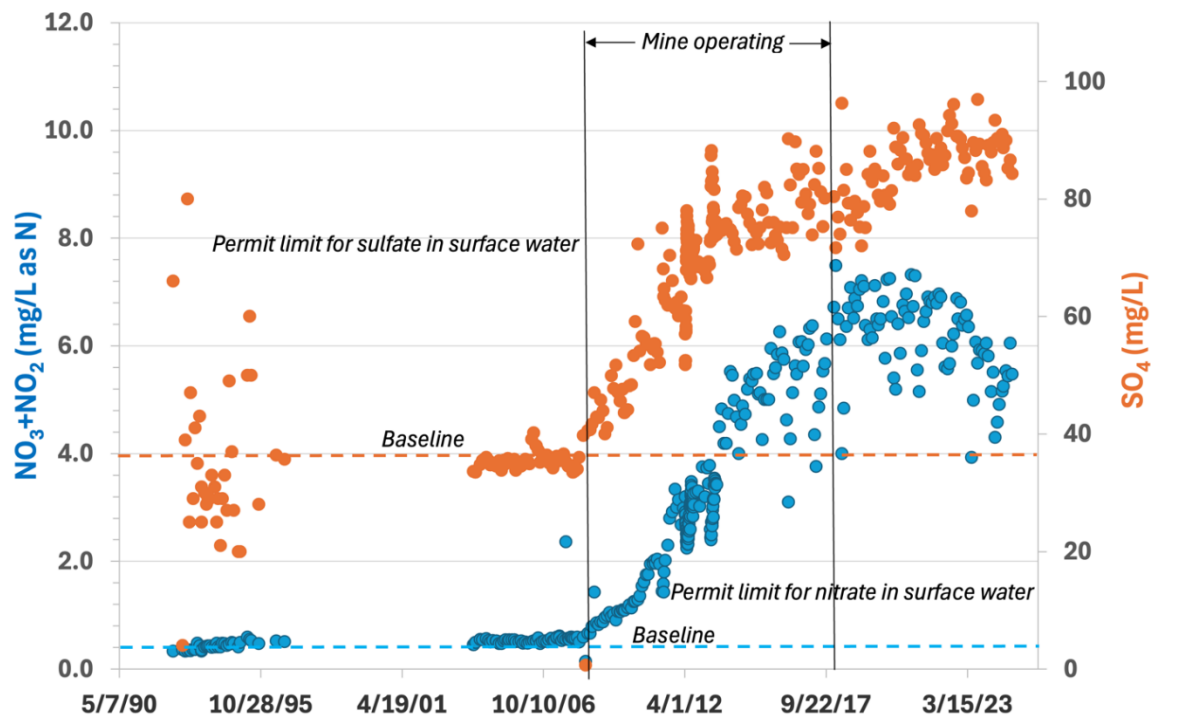
**Buckhorn Figure 8. Nitrate+nitrite and sulfate concentration in the Roosevelt Adit at GW2, outside the capture zone boundary, downgradient of the Gold Bowl and Southwest Zones of the underground mine.** Monthly average permit limits: sulfate 72 mg/l, nitrate+nitrite 0.32 mg/l as N. Graphs created using data from database maintained by Okanogan Highlands Alliance.

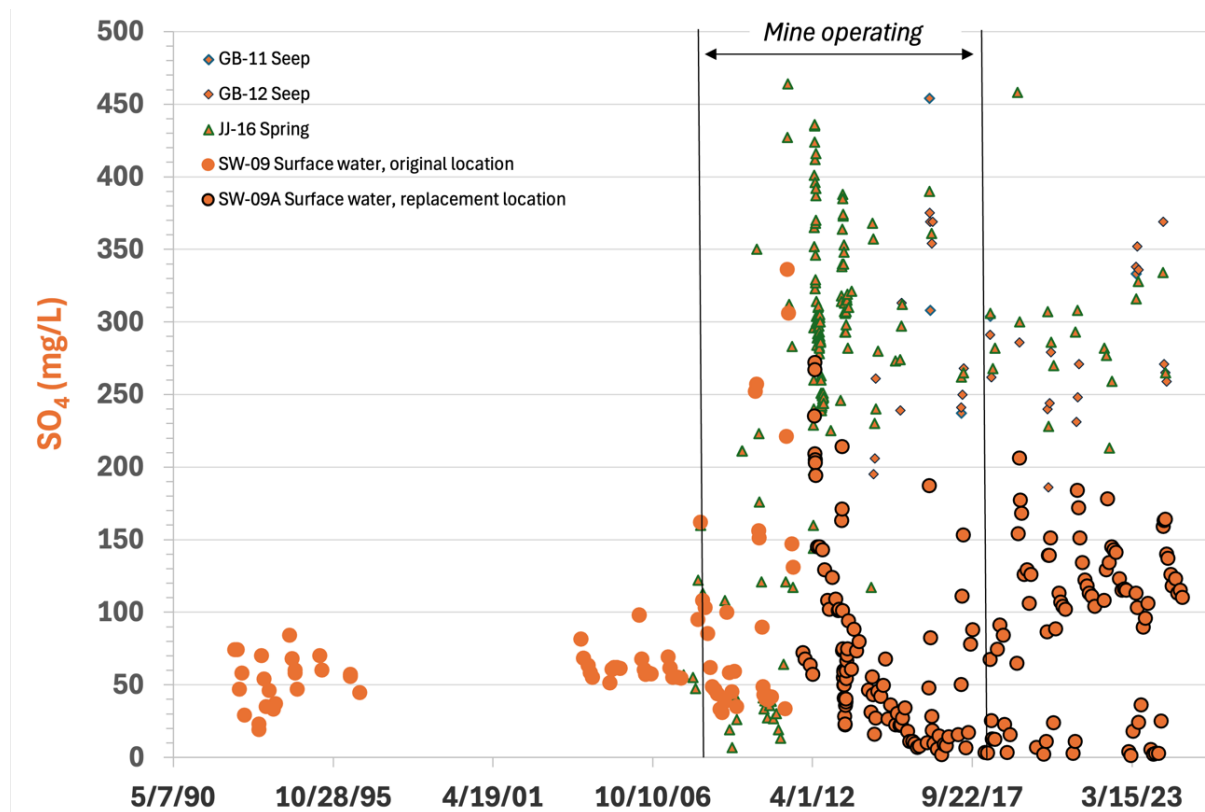
**Buckhorn Figure 9. Sulfate concentrations in Gold Bowl Creek at SW9/9A, outside the capture zone boundary, downgradient of the Gold Bowl Zone of the underground mine.** Permit limit in surface water, monthly average: sulfate in 72 mg/l; permit limit in groundwater, seeps, and springs, monthly average: sulfate 69.5 mg/l. Graphs created using data from database maintained by Okanogan Highlands Alliance.

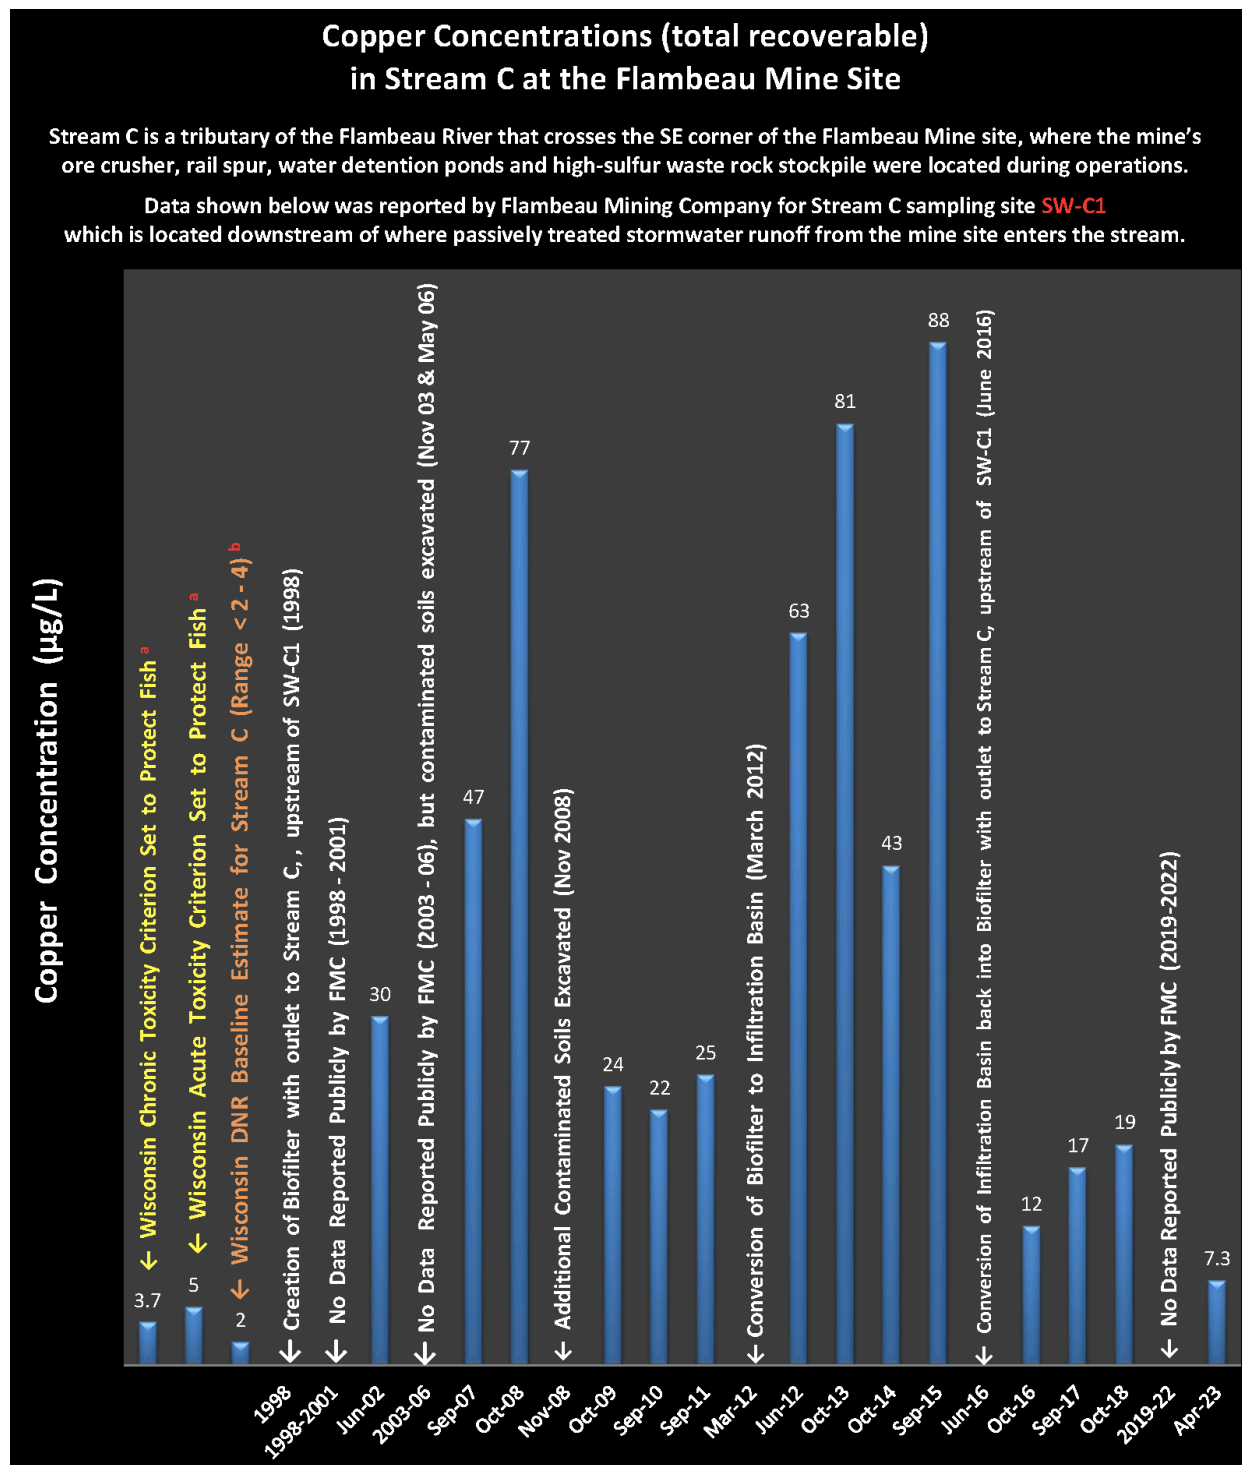
**Flambeau Figure 7. Copper concentrations in Stream C, with information about mine operations and chronic and acute toxicity values.** Wisconsin Administrative Code, NR 105.06 (Nov 2008); Hardness-dependent toxicity; CTC value of 3.7 µg/L and ATC value of 5.0 µg/L (Total Recoverable) were calculated for a hardness of 30 mg/l (Hardness measured at SW-C1 in April 2023 was 27 mg/l). FMC failed to report baseline surface water quality data for Stream C. In 2010, however, Wisconsin DNR field staff identified a nearby stream deemed appropriate to use for estimating Stream C baseline conditions. A mean copper concentration of 2.2 µg/L was measured in the stream (range = <2-4; n = 5).

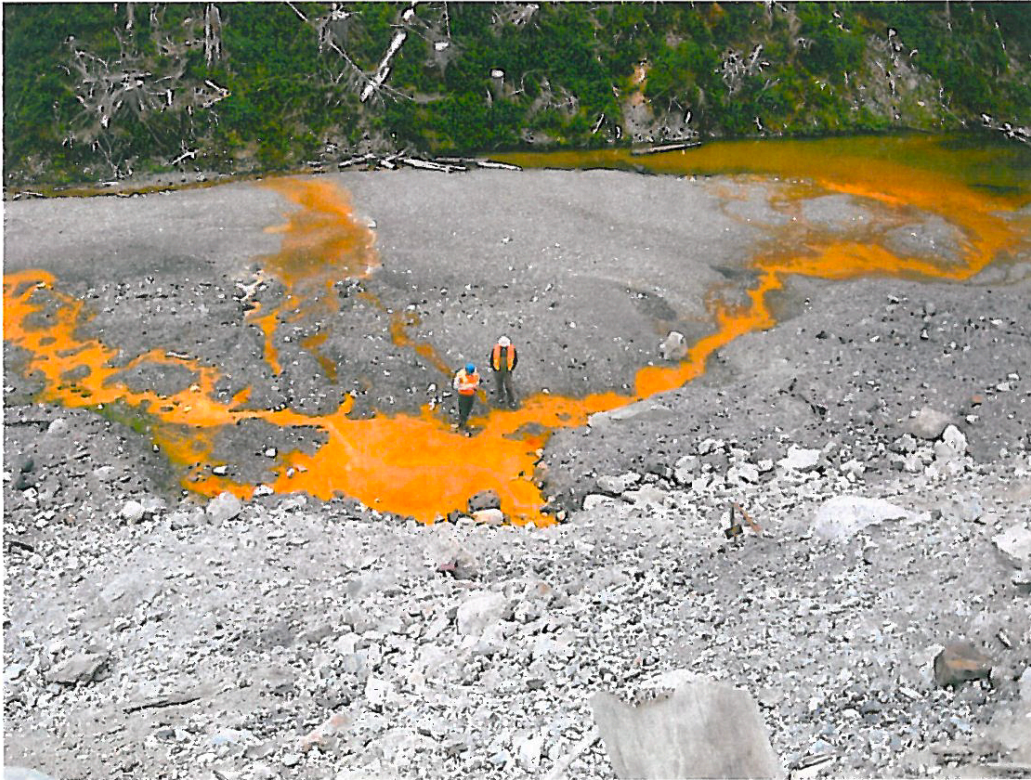
**Kensington Figure 2. Acidic waste rock seeps flowing into the tailings facility, 2013.** See Table 1 for water quality results. *Source: ADEC, 2013. Notice of Violation. Kensington.NOV.ADEC 2013.pdf [6]*
