**Modern Mine Study:  
Water Quality Performance and Predictions at U.S.  
Mines Permitted Since 1990**

**Prepared by Northeastern Minnesotans for Wilderness  
exclusively for Minnesota State regulatory agencies**

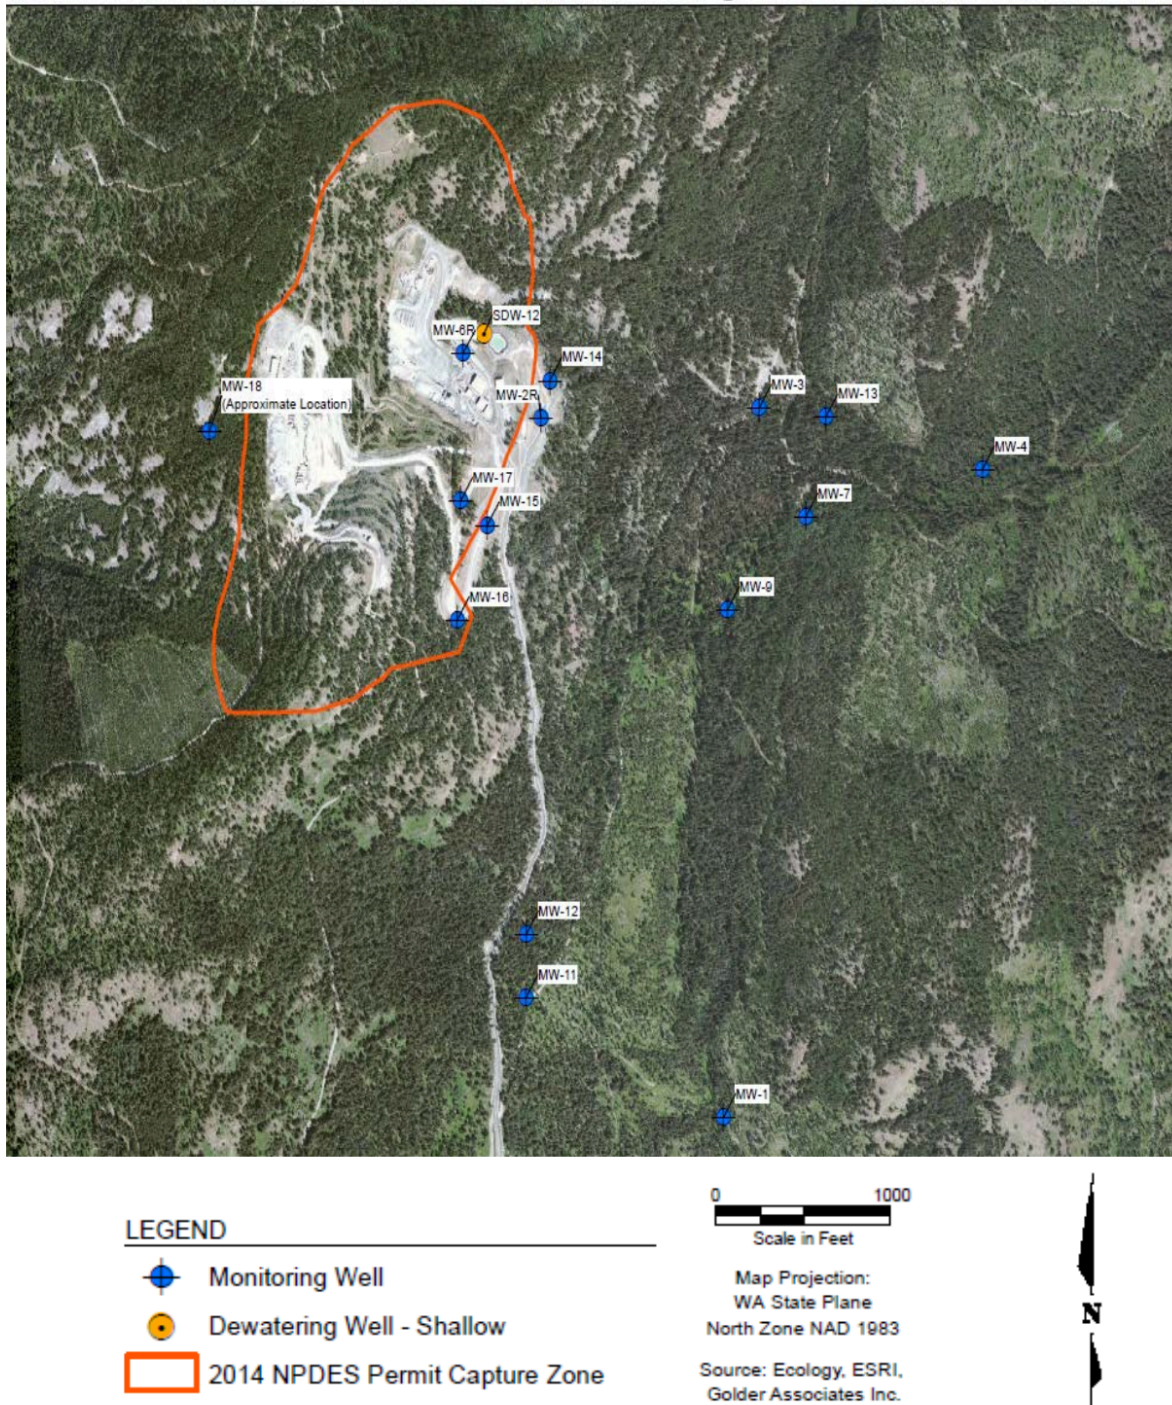
**Buckhorn Figure 4. Buckhorn Mine Groundwater Monitoring Locations.**

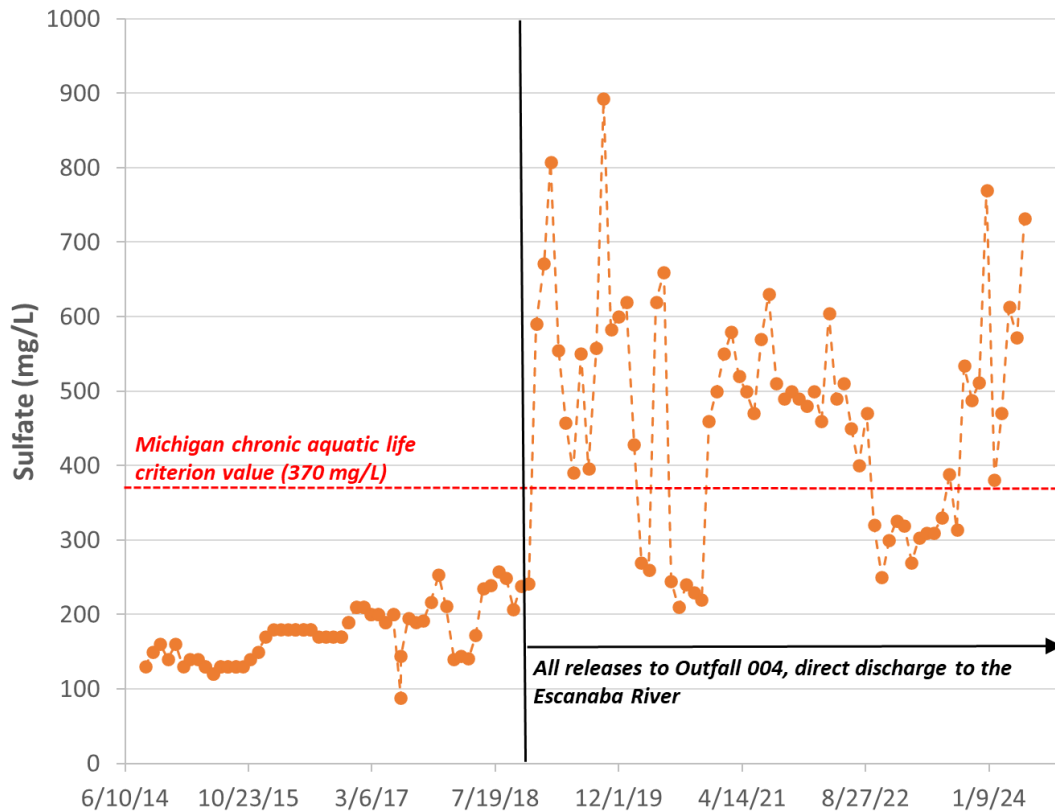
**Eagle Figure 3. Sulfate concentrations in Humboldt Mill treated effluent released to outfalls, 2014 to 2024.** Data source: Humboldt NPDES Dataset. *Eagle.Humboldt NPDES dataset.xlsx*

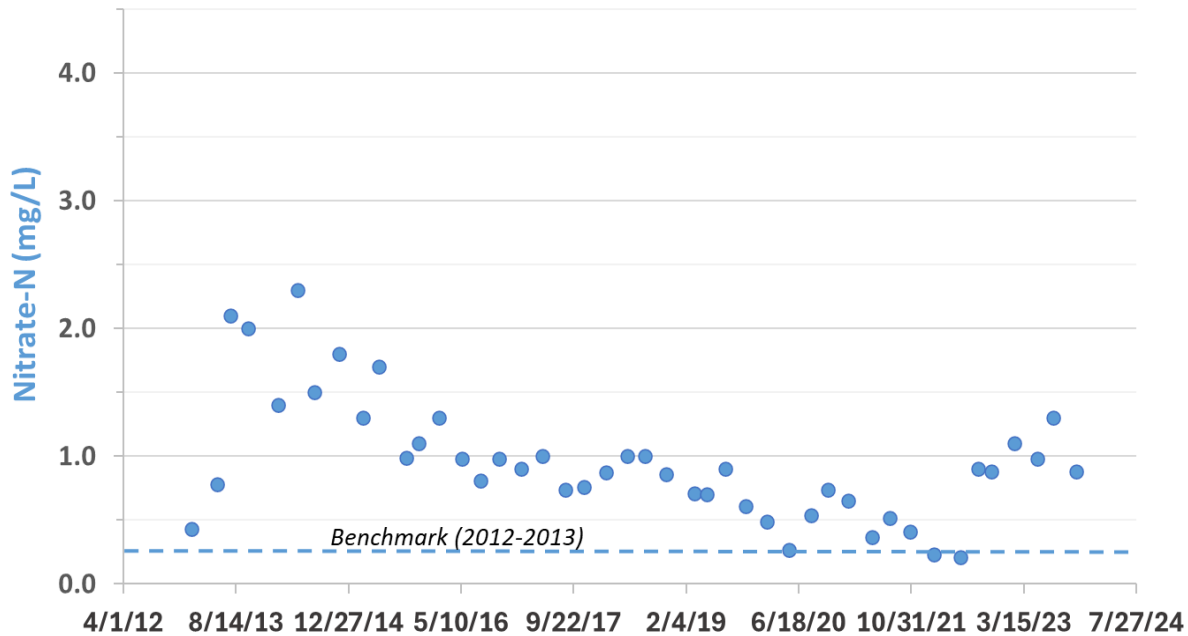
situation illustrates the impacts that land development and transportation at the level required for mining operations has on groundwater. These results also illustrate the failure of environmental review, which in this case completely ignored potential impacts on groundwater from deicing and other sources mobilized by stormwater.<sup>310</sup>

**Eagle Figure 5a. Nitrate concentrations over time in alluvial well QAL-67A compared to the benchmark.**

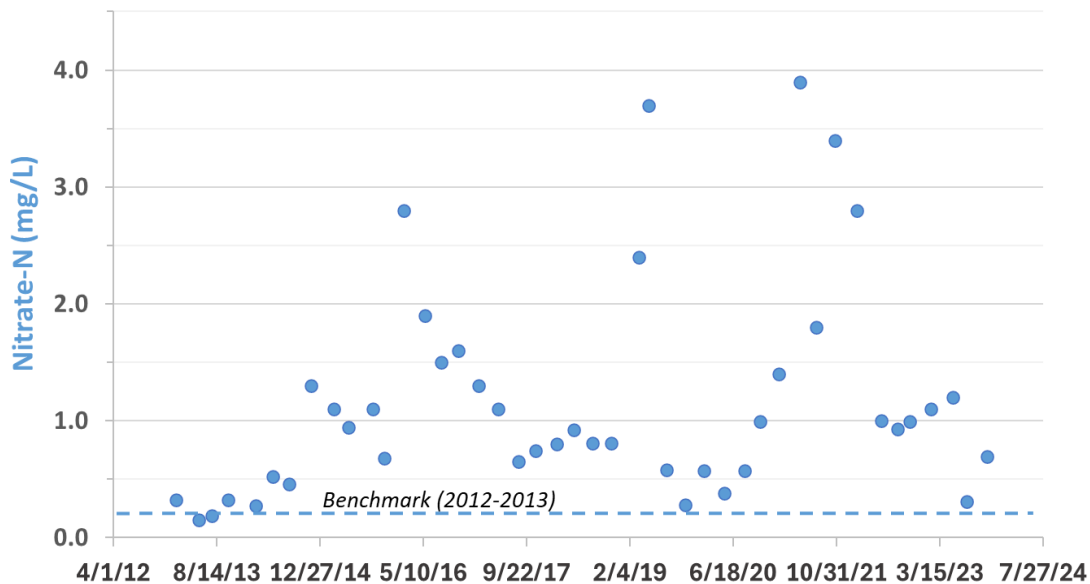
**Eagle Figure 5b. Nitrate concentrations over time in alluvial well QAL-24A compared to the benchmark.**

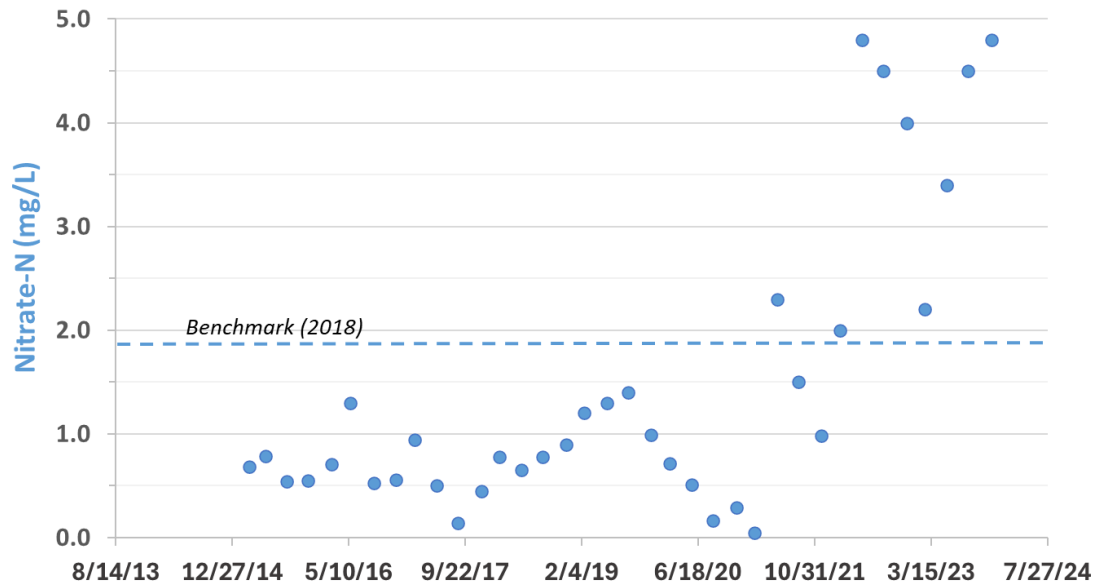
**Eagle Figure 6a. Nitrate concentrations over time in MW-701, inside the cut-off wall, compared to the benchmark value.** Date source: Eagle Mine, 2015-2023 Annual Mining and Reclamation Reports, Humboldt Mill. *Eagle.Humboldt spreadsheet.Feb2025.xlsx*

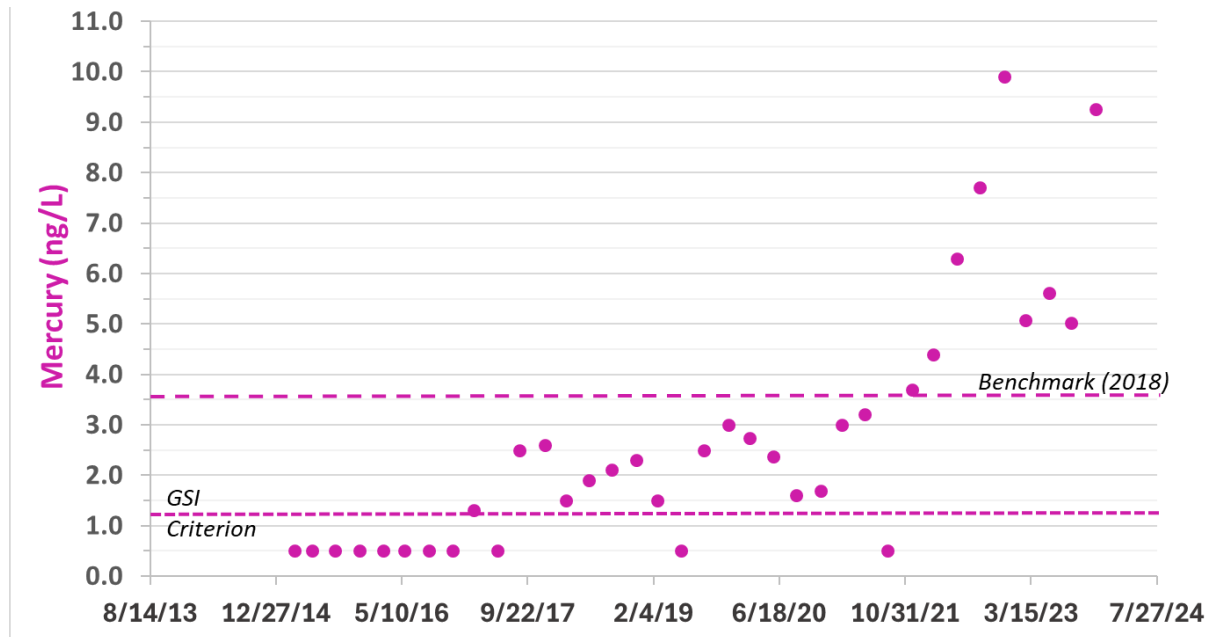
**Eagle Figure 6b. Mercury concentrations over time in MW-702, inside the cut-off wall, compared to groundwater-surface water interface (GSI) criterion (1.3 ng/l) and the benchmark value.**

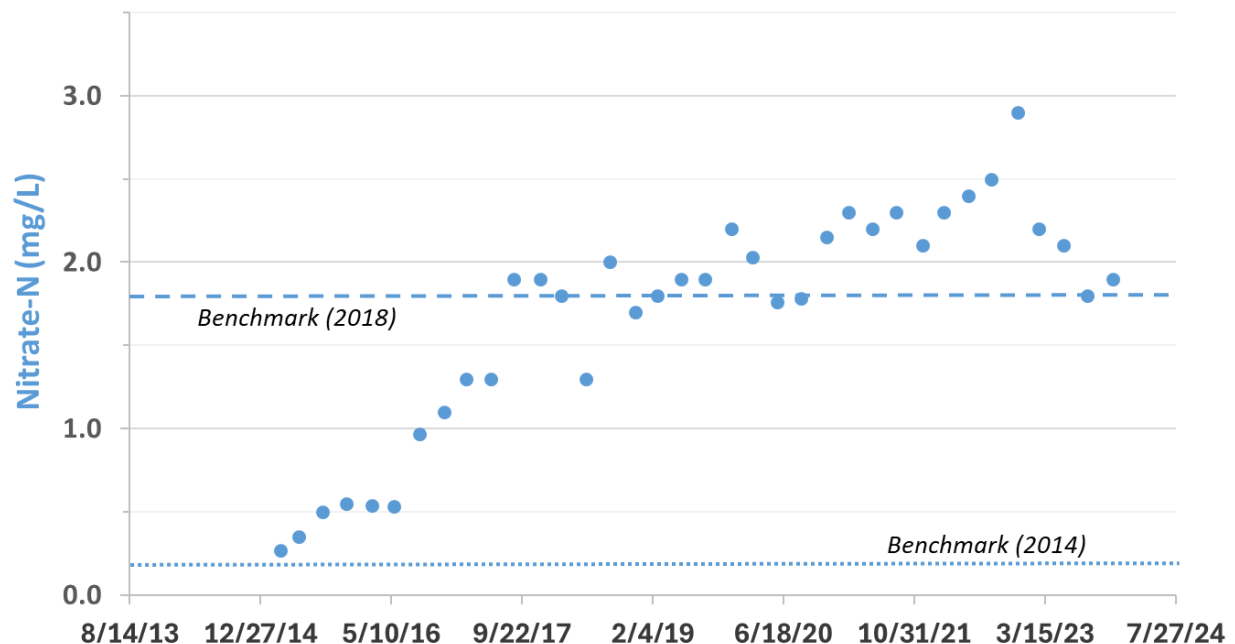
benchmark). The higher concentrations compared to the 2015 values indicate that nitrate is migrating from the impoundment beyond the cut-off wall.

**Eagle Figure 6c. Nitrate concentrations over time in MW-703, outside the cut-off wall and paired with MW-702, compared to the 2014 and 2018 benchmark values.** Data sources: Eagle Mine, 2015-2023 Annual Mining and Reclamation Reports, Humboldt Mill. *Eagle.Humboldt spreadsheet.Feb2025.xlsx*

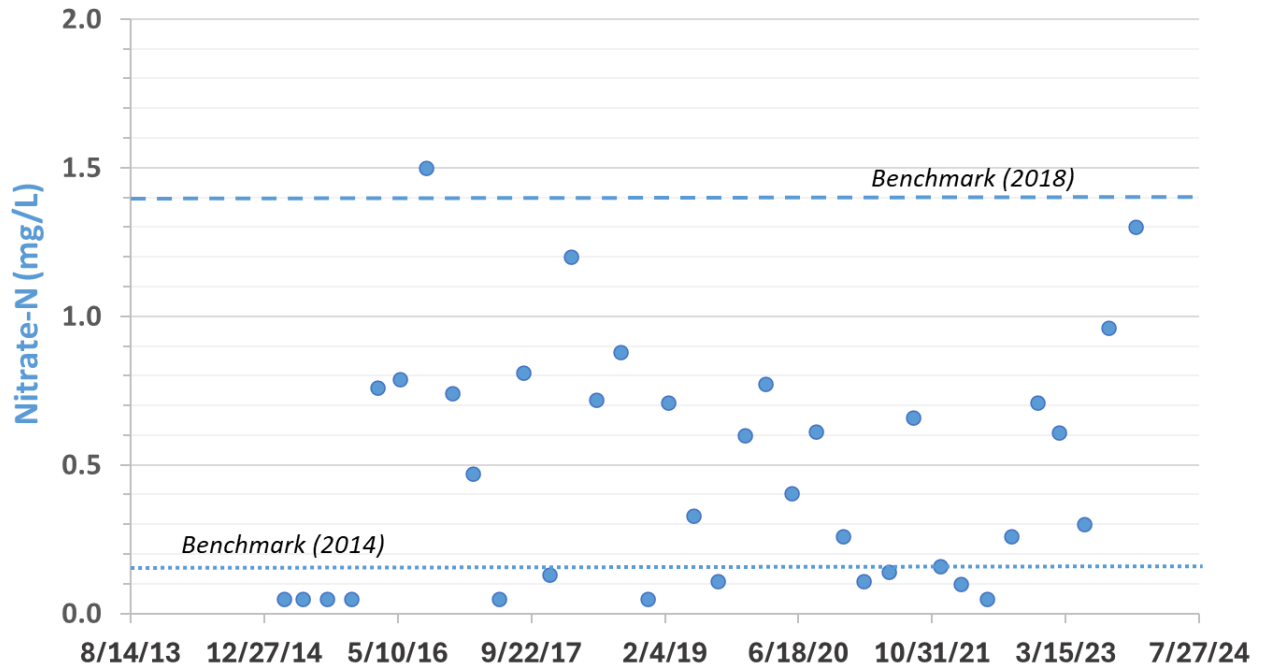
**Eagle Figure 6d. Nitrate concentrations over time in MW-704, the compliance well outside the cut-off wall, compared to the 2014 and 2018 benchmark values.** Data sources: Eagle Mine, 2015-2023 Annual Mining and Reclamation Reports, Humboldt Mill. *Eagle.Humboldt spreadsheet.Feb2025.xlsx*

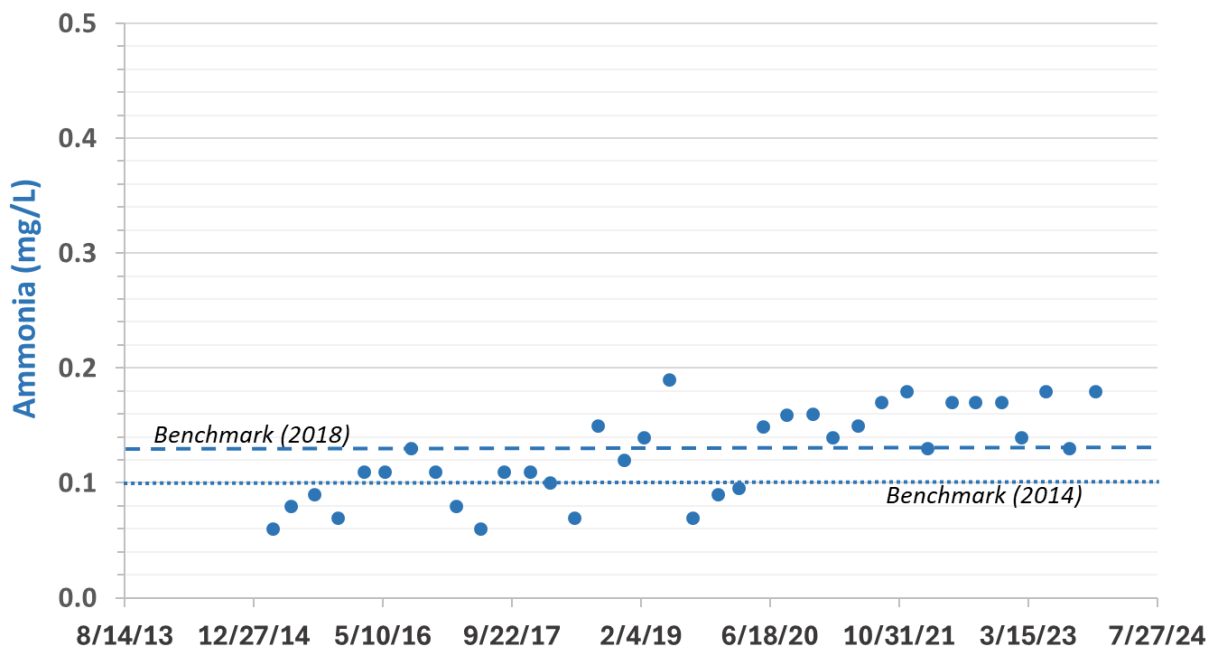
Well MW-705 is located near the edge of the alluvial aquifer with no cut-off wall between it and the impoundment. Benchmark ammonia values did not change markedly between 2014 and 2018, but 80% of the values after mid-2018 are higher than the less protective 2018 benchmark value (Figure 6e). Overall, the results suggest that the cut-off wall is ineffective in preventing downgradient contaminant migration from the tailings impoundment.

**Eagle Figure 6e. Ammonia concentrations over time in MW-705, outside the cut-off wall, compared to the 2014 and 2018 benchmark values.** Data sources: Eagle Mine, 2015-2023 Annual Mining and Reclamation Reports, Humboldt Mill. *Eagle.Humboldt spreadsheet.Feb2025.xlsx*

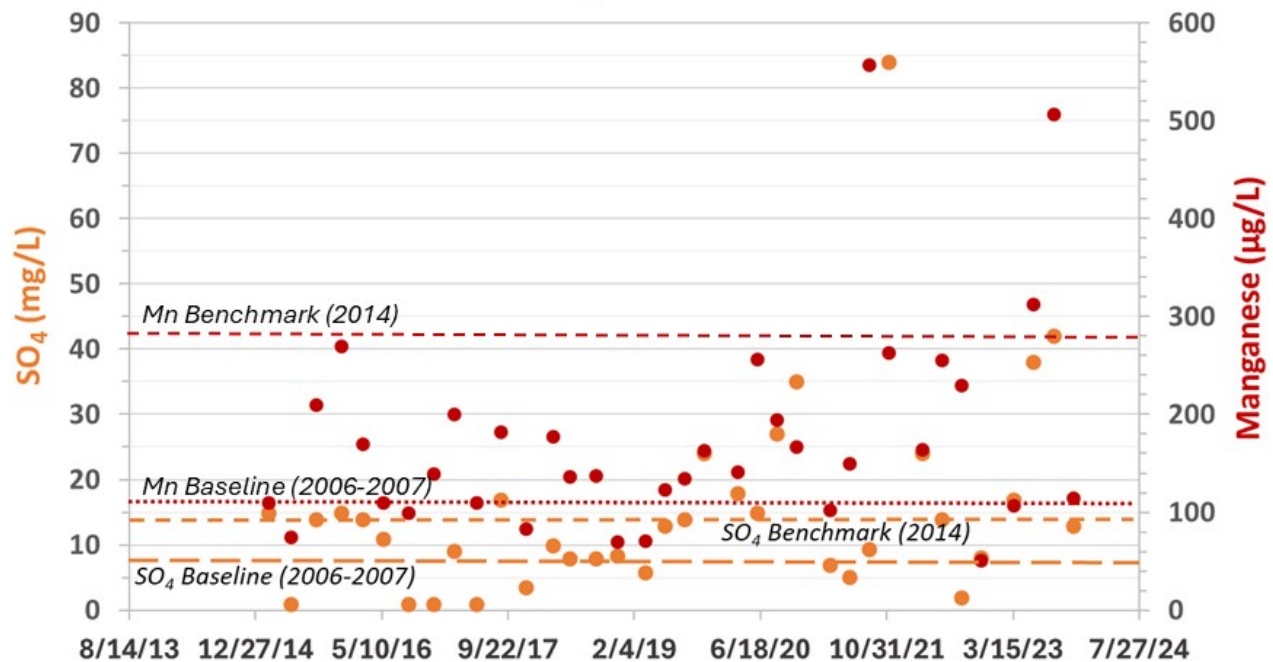
Concentrations of several constituents, including specific conductance, sulfate, iron, and manganese, have risen at MER-003, as shown in Table 2. Figure 9 shows sulfate and manganese concentrations at MER-003 over time. Note that discharge in 2015 was to wetlands; the effect on the river was likely not as immediate as in later years, when discharge was directly to the river. Iron and manganese concentrations also rose in MER-002, which might be affected by groundwater pathways between the HTDF and the river. These levels do not exceed Michigan's water quality standards. However, Michigan does not have a sulfate standard to protect wild rice. In Minnesota, that standard is 10 mg/l.

**Figure 9. Sulfate and manganese concentrations over time in the Escanaba River, most downstream monitoring location, MER-003.** Data sources: Eagle Mine, 2015-2023 Annual Mining and Reclamation Reports, Humboldt Mill. *Eagle.Humboldt spreadsheet.Feb2025.xlsx*

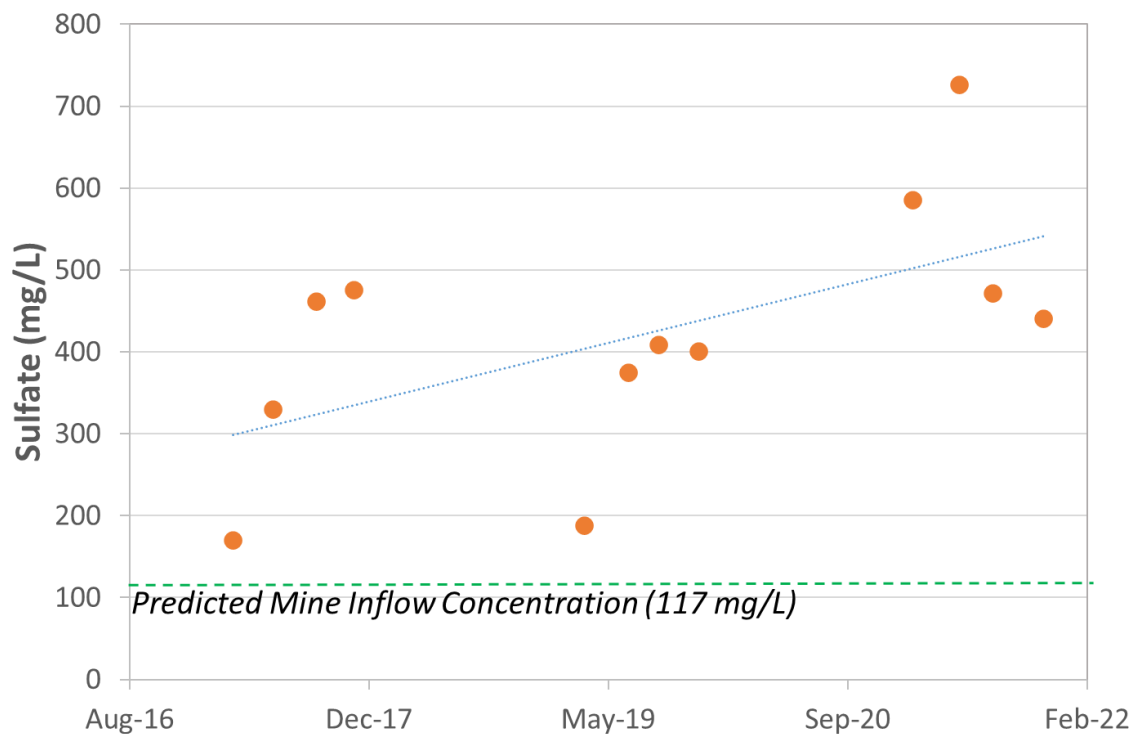
As indicated in Tables 3 and 4 and Figures 10a and 10b, both water pumped from the underground mine and TDRSA leachate are of much poorer quality than predicted. A few parameters worsened after the expansion into the Eagle East orebody began in 2018. This ore body was not considered in the original predictions, nor were predictions updated for the expansion. The application for the amended permit states, "Based on the strong geological and geochemical similarities, there is no basis for believing that the new development rock would behave any differently than did the originally tested country rock."<sup>321</sup> According to the EIA, the exception was for total dissolved solids, which are much higher at the Eagle East orebody.<sup>322</sup> However, after 2018, sulfate, barium, and iron levels have been considerably higher in mine inflow water and sulfate, chloride, cobalt, and manganese have been considerably higher in TDRSA water.

**Figure 10a. Comparison of predicted vs. actual sulfate concentrations in composite mine inflow. Actual**

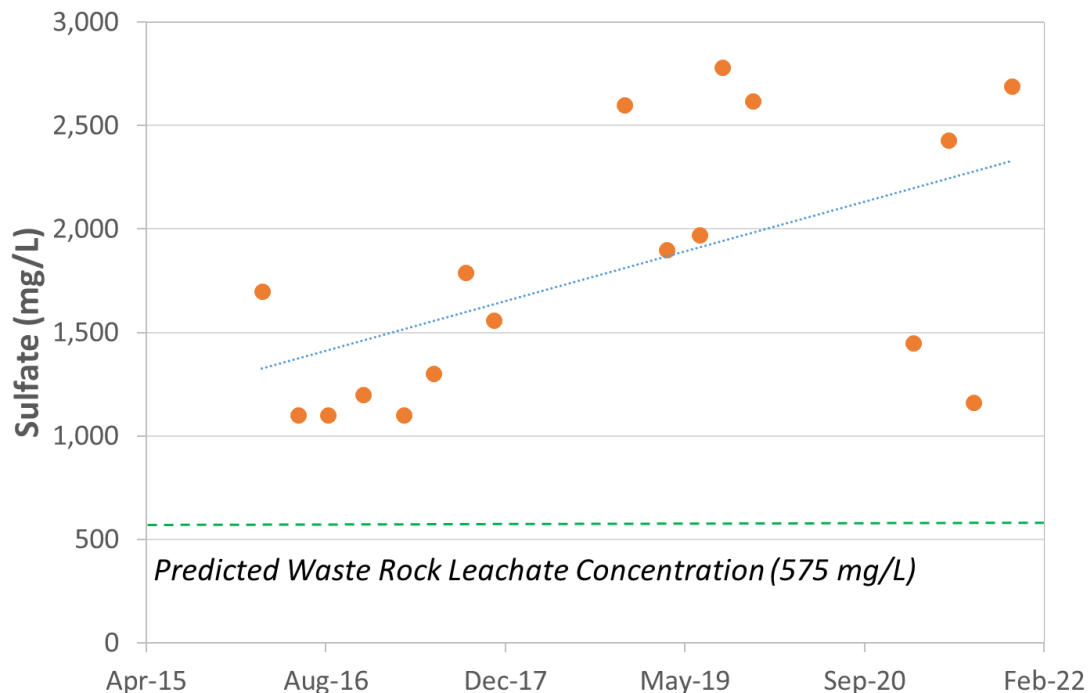
**Eagle Figure 10b. Comparison of predicted vs. actual sulfate concentrations in waste rock leachate.**

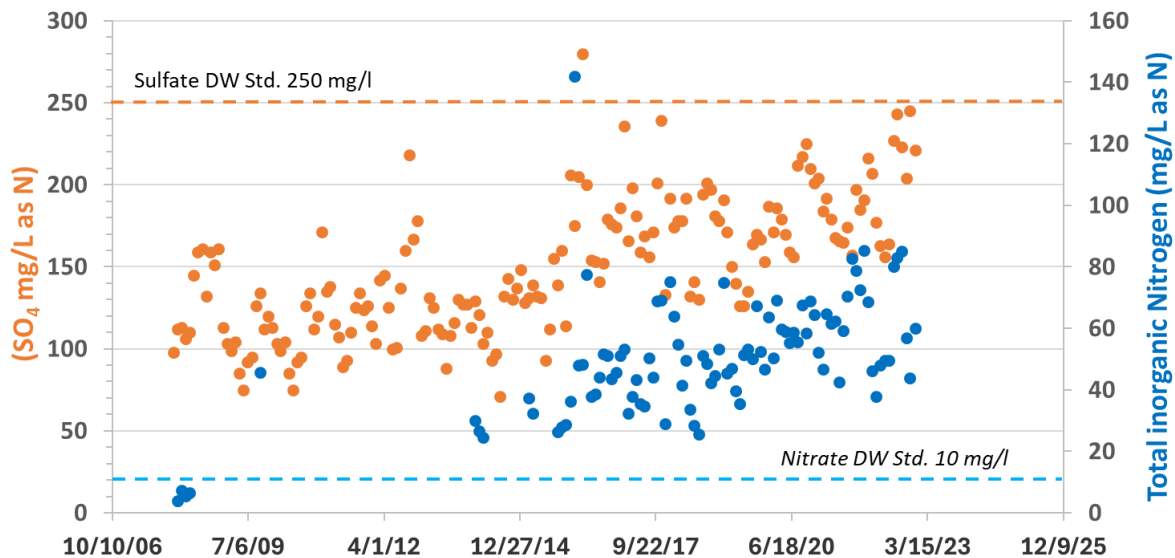
**East Boulder Figure 2. Nitrate+nitrite and sulfate concentrations in adit water from 2008 to 2022, with drinking water standards for comparison.** Data sources: Stillwater Mining Company 2008 to 2022 Annual Reports. See *East Boulder.Monitoring Data Spreadsheet.Feb2025.xlsx*

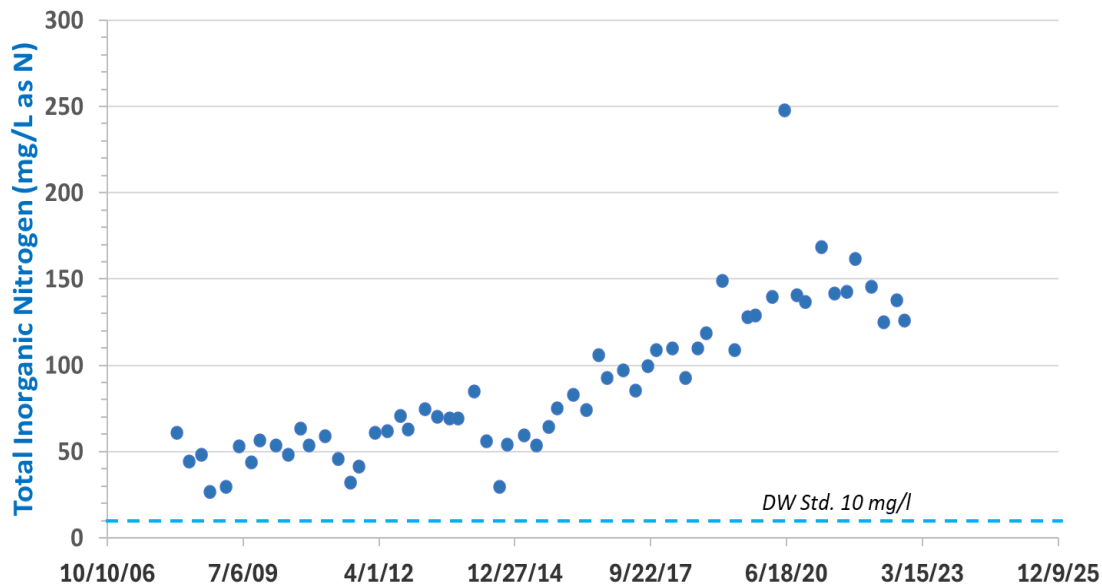
As shown in Figure 3a and b, nitrate and sulfate concentrations in tailings pond water have been increasing since approximately 2008 for nitrate, and since about 2012 for sulfate. All nitrate values exceeded the drinking water standard (for comparison). Since early 2012 nearly all sulfate concentrations exceeded the drinking water standard (for comparison).

**East Boulder Figure 3a. Total inorganic nitrogen concentrations in tailings pond water, 2008 to 2022, with the drinking water standard for comparison.** Data sources: Stillwater Mining Company 2008 to 2022 Annual Reports. See *East Boulder.Monitoring Data Spreadsheet.Feb2025.xlsx*

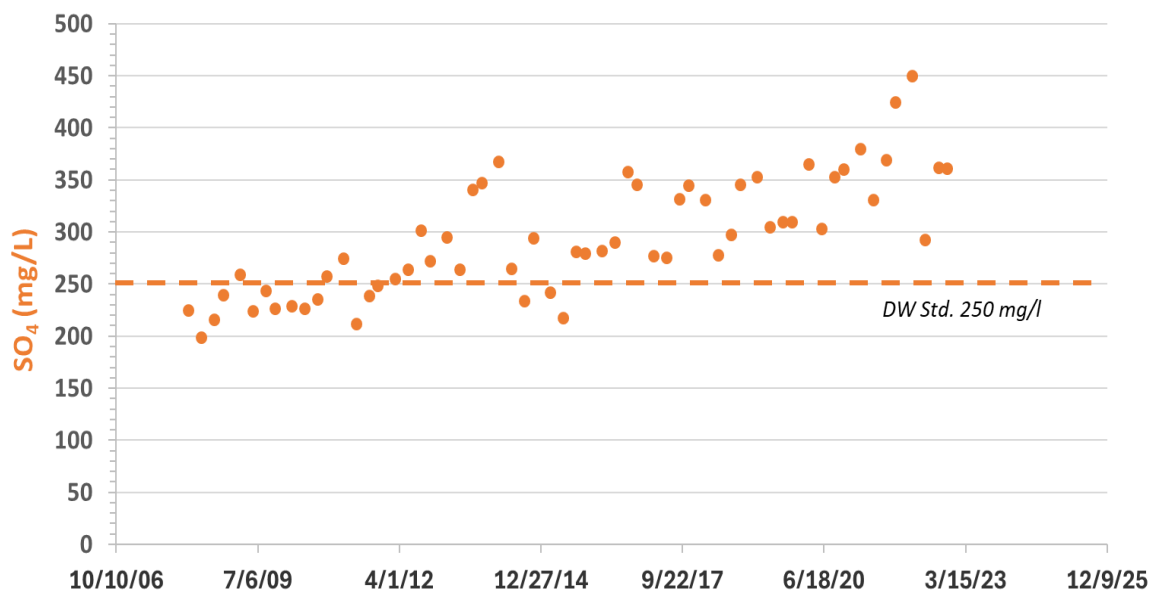
**East Boulder Figure 3b. Sulfate concentrations in tailings pond water, 2008 to 2022, with the drinking water standard for comparison.** Data sources: Stillwater Mining Company 2008 to 2022 Annual Reports. See *East Boulder.Monitoring Data Spreadsheet.Feb2025.xlsx*

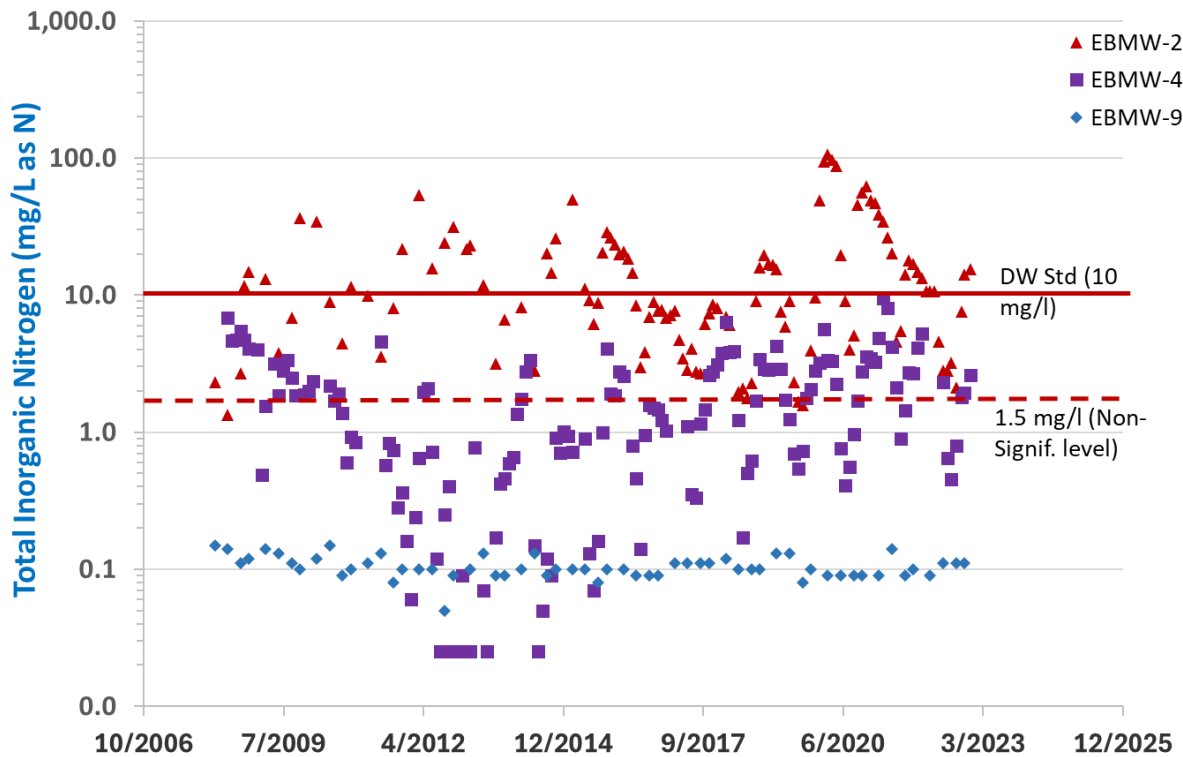
**East Boulder Figure 5a. Total inorganic nitrogen concentrations in three groundwater monitoring locations from 2008 to 2022: EBMW-9 (unimpacted), EBMW-4 (downgradient of percolation ponds, above tailings impoundment, and EBMW-2 (just upgradient of compliance location and 250 ft upgradient of the East Boulder River)).** The data are plotted on a log scale to be able to see the low concentrations in EBMW-9. The non-significance level and the drinking water standard are included for comparison. *Data sources:* Stillwater Mining Company 2008 to 2022 Annual Reports. See *East Boulder Monitoring Data Spreadsheet.Feb2025.xlsx*

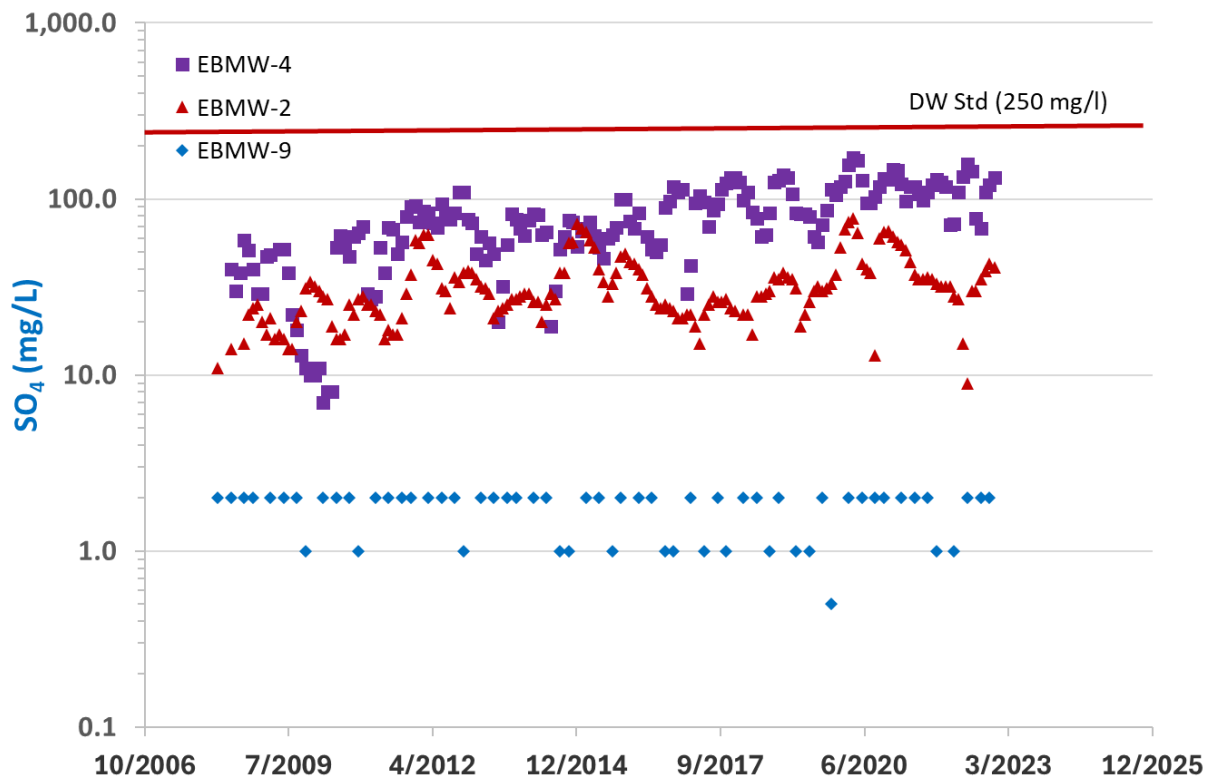
**East Boulder Figure 5b. Sulfate concentrations in three groundwater monitoring locations from 2008 to 2022: EBMW-9 (unimpacted), EBMW-4 (downgradient of percolation ponds, above tailings impoundment, and EBMW-2 (just upgradient of compliance location and 250 ft upgradient of the East Boulder River)).** The data are plotted on a log scale to be able to see the low concentrations in EBMW-9. The drinking water standard is included for comparison. *Data sources:* Stillwater Mining Company 2008 to 2022 Annual Reports. See *East Boulder.Monitoring Data Spreadsheet.Feb2025.xlsx*

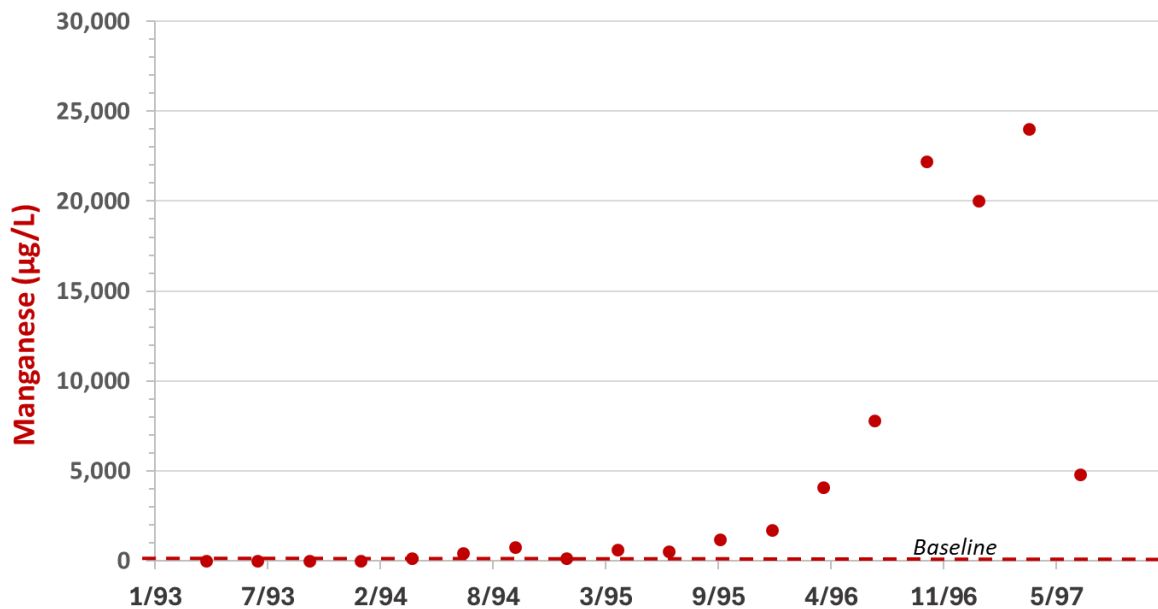
Leachate from the Type II Stockpile (high sulfur stockpile) was very high in manganese (up to 24,000 mg/l) and copper (up to 450 mg/l), with a pH dropping to 3.1; sulfate ranged up to 1400 mg/l (Figures 2a – 2d).<sup>424</sup> A seep at the Type I Stockpile (low sulfur stockpile) contained copper at up to 53.2 mg/l, had a minimum pH measurement of 5.2, and had a maximum conductivity measurement of 1402  $\mu\text{S}/\text{cm}$ .<sup>425</sup> A lysimeter installed below the Type I Stockpile measured rising manganese levels that reached 1500  $\mu\text{g}/\text{l}$  in 1997 (Figure 3).<sup>426</sup> These results demonstrate that even materials designated as "non-potentially acid generating" can leach high concentrations of metals and other solutes.

**Flambeau Figure 2a. Manganese concentrations in Type II leachate (high sulfur stockpile) from 1994 to 1997.** Data sources: Flambeau annual reports, 1993-1997. *Flambeau DMRs* (folder). See *Flambeau.Flambeau Data Spreadsheet.Feb2025.xlsx [Type II Leachate]*

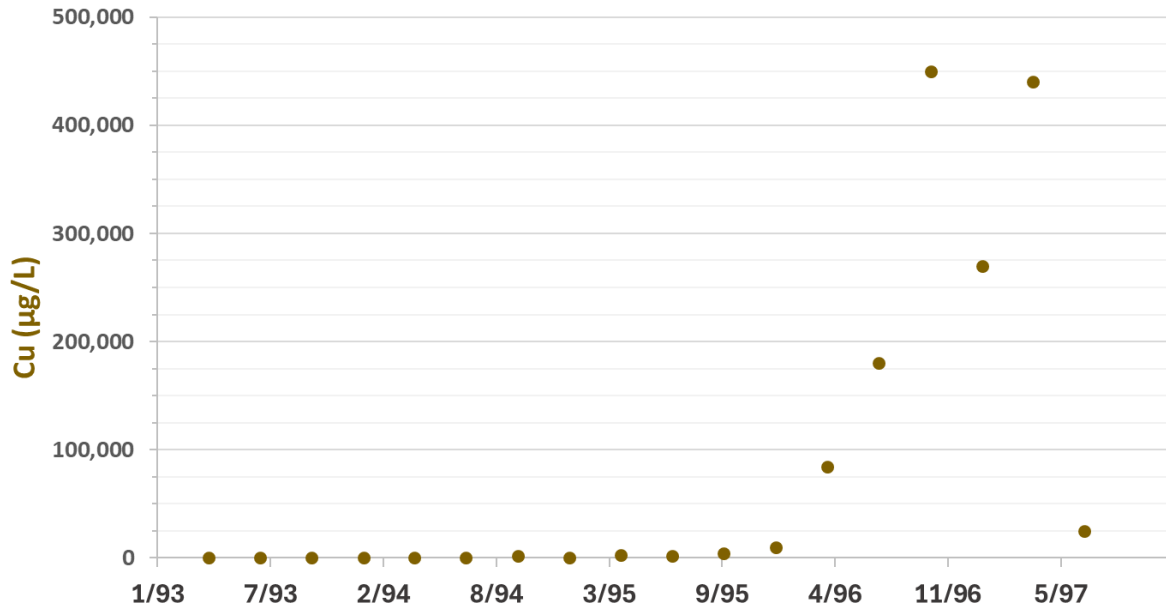
**Flambeau Figure 2b. Copper concentrations in Type II leachate (high sulfur stockpile) from 1994 to 1997.** Data sources: Flambeau annual reports, 1993-1997. *Flambeau DMRs* (folder). See *Flambeau.Flambeau Data Spreadsheet.Feb2025.xlsx [Type II Leachate]*

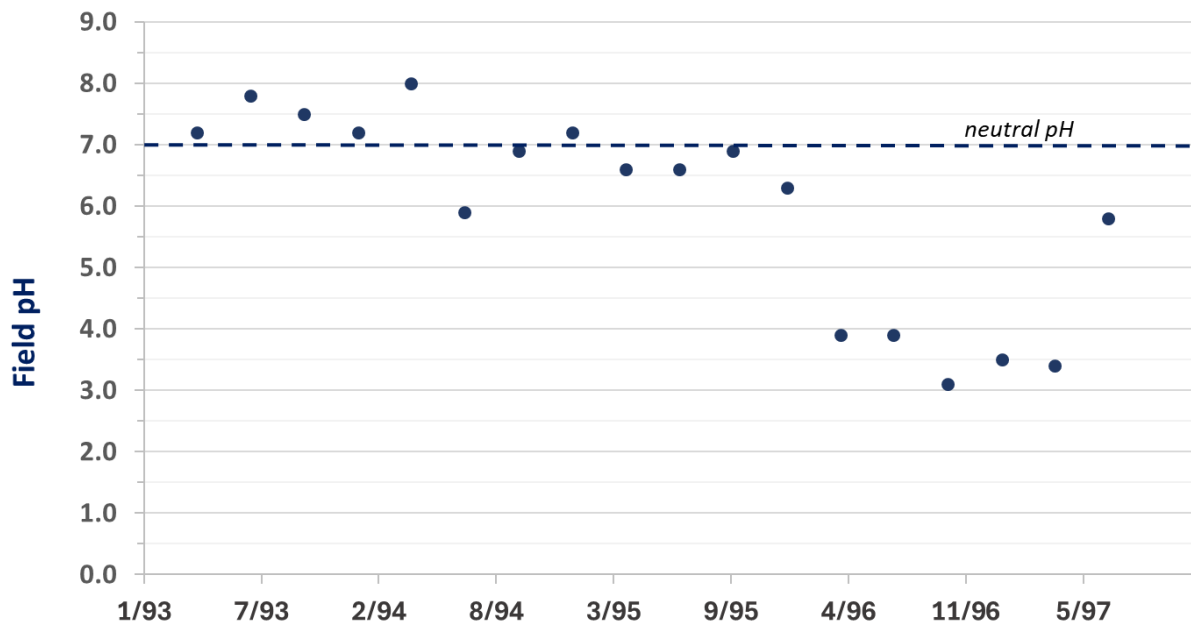
**Flambeau Figure 2c. Field pH values in Type II leachate (high sulfur stockpile) from 1994 to 1997.**

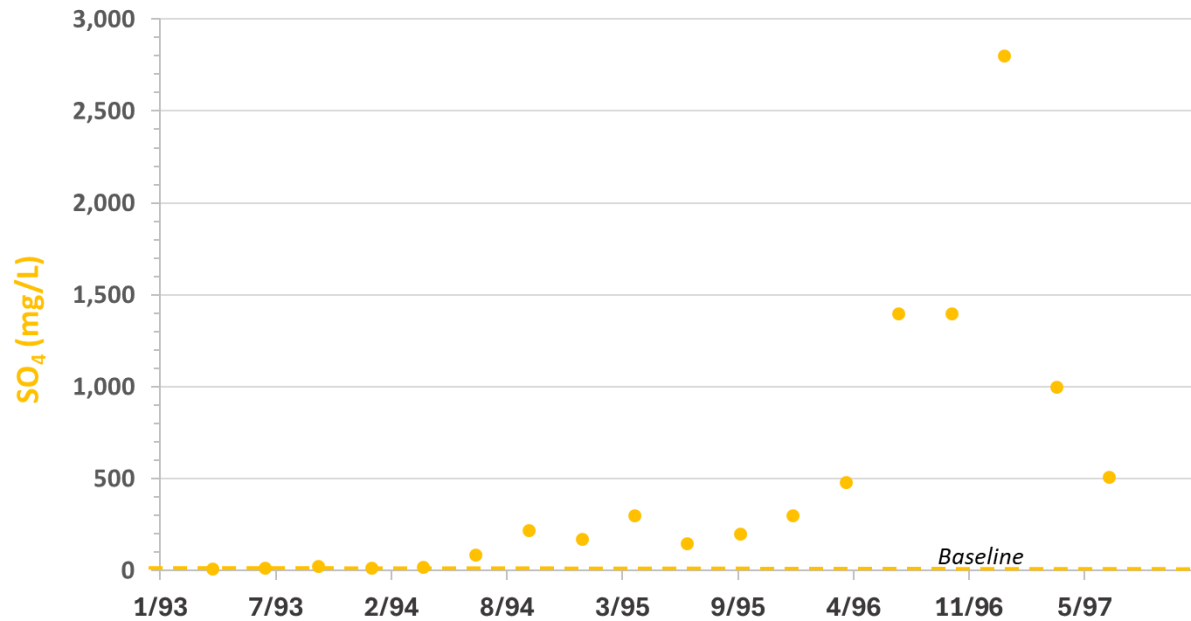
**Flambeau Figure 2d. Sulfate concentrations in Type II leachate (high sulfur stockpile) from 1994 to 1997.** Data sources: Flambeau annual reports, 1993-1997. *Flambeau DMRs* (folder). See *Flambeau.Flambeau Data Spreadsheet.Feb2025.xlsx [Type II Leachate]*

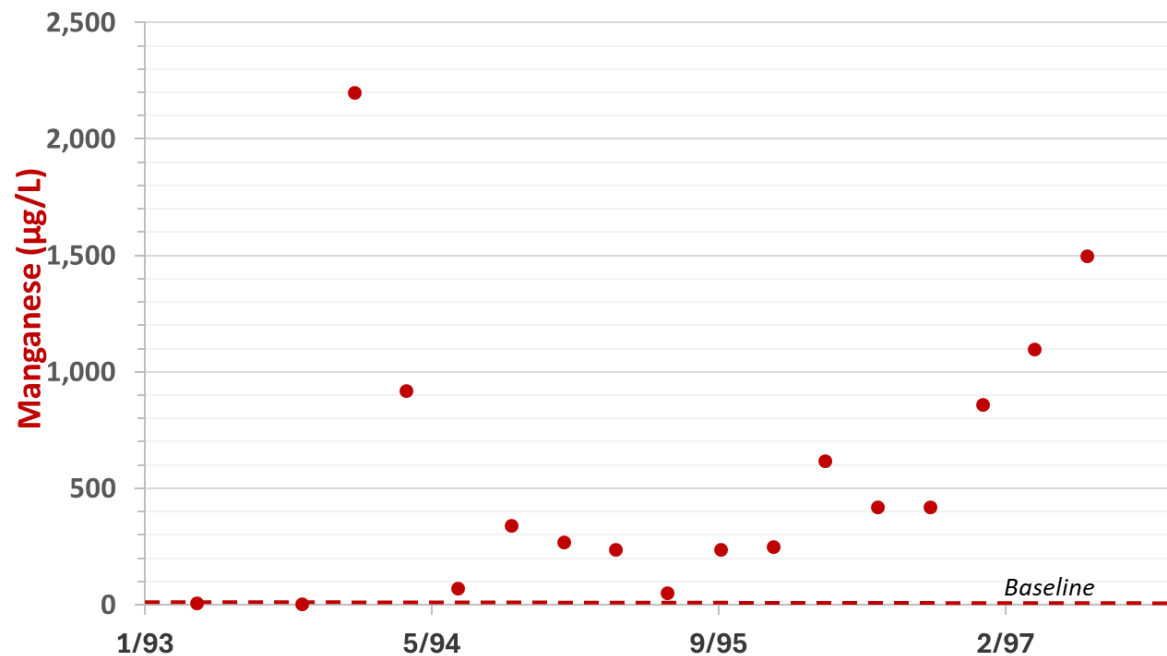
**Flambeau Figure 3. Manganese concentrations in Type I leachate (low sulfur stockpile) from 1994 to 1997.** Data sources: Flambeau annual reports, 1993-1997. *Flambeau DMRs* (folder). See *Flambeau.Flambeau Data Spreadsheet.Feb2025.xlsx [Type I Lysimeter]*

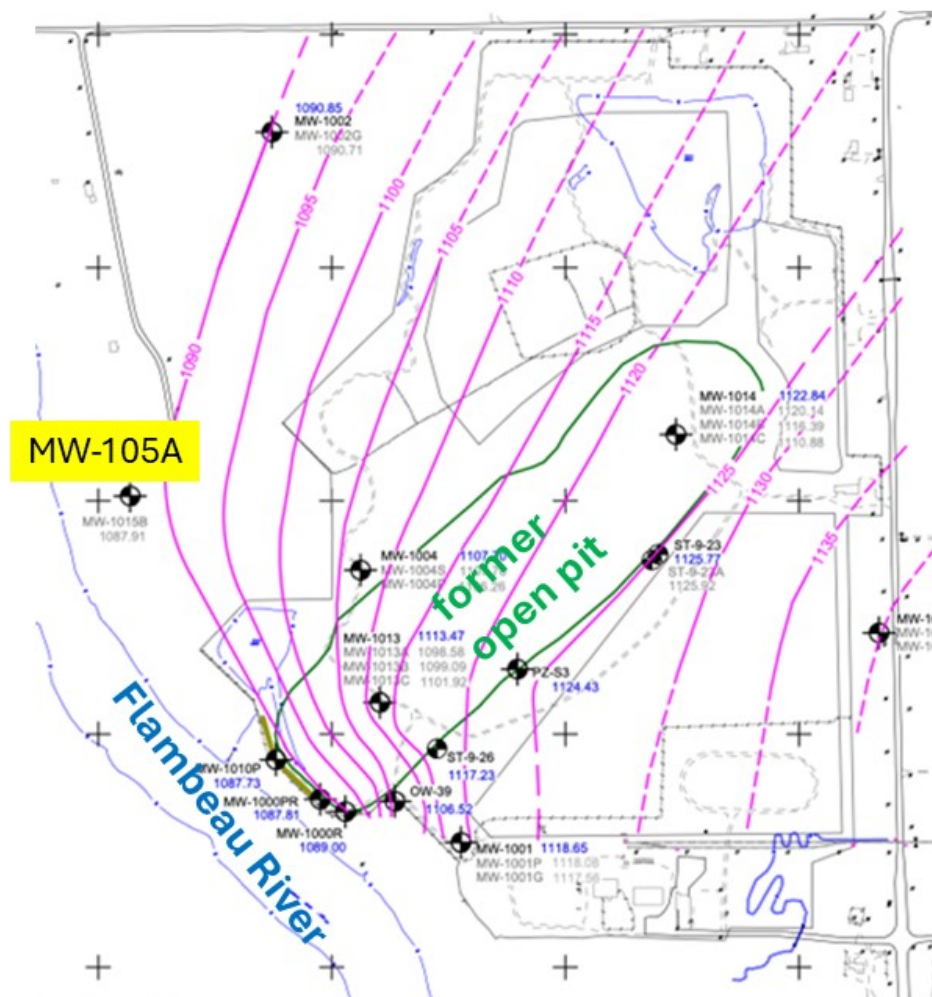
**Flambeau Figure 4. Shallow groundwater potentiometric surface map, November 2023.**

The only designated compliance well (MW-1015A) is located not where it is likely to intercept the flow path, but at the location closest to the flow path that is on the same side of the river as the mine and 1200 feet from mine features (Figure 4). (The shortest flow path from the pit is intercepted by the river before reaching the compliance boundary; the assumption is that any flow from the pit enters the river and does not affect groundwater at the compliance boundary beyond the river.<sup>437</sup>) Baseline data specific to MW-1015A do not exist, but groundwater does not appear to be significantly degraded at this location.<sup>438</sup>

MW-105A is the only compliance monitoring location in groundwater.

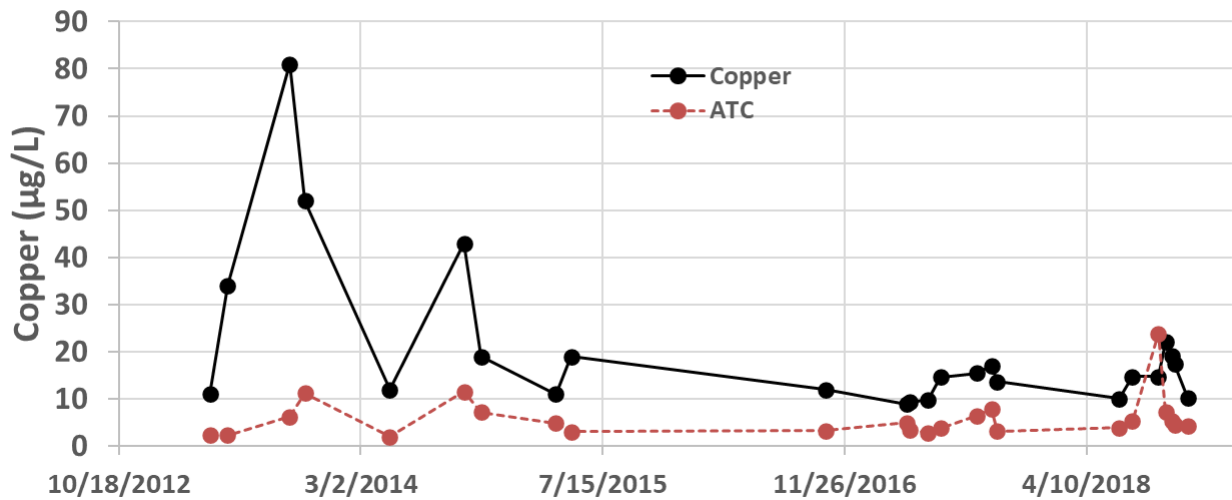
Surface water impacts have become apparent in a small tributary stream (Stream C), for which there are no baseline data.<sup>456</sup> Copper has consistently exceeded the acute toxicity criterion (ATC) value since 2002, and zinc has occasionally exceeded the ATC, as shown in Figures 6a and b.<sup>457,458,459,460</sup> The acute criterion is the value that would adversely affect aquatic life in a short period of time, whereas the chronic criterion is the value that would adversely affect aquatic life only after a longer period of time. Chronic and acute values are hardness-dependent, which explains the variability in ATC values in Figures 6a and b. At higher hardness values, copper and zinc are less toxic to aquatic biota. Pollution in Stream C

**Flambeau Figure 7. Copper concentrations in Stream C, with information about mine operations and chronic and acute toxicity values.** Wisconsin Administrative Code, NR 105.06 (Nov 2008); Hardness-dependent toxicity; CTC value of 3.7 µg/L and ATC value of 5.0 µg/L (Total Recoverable) were calculated for a hardness of 30 mg/l (Hardness measured at SW-C1 in April 2023 was 27 mg/l). FMC failed to report baseline surface water quality data for Stream C. In 2010, however, Wisconsin DNR field staff identified a nearby stream deemed appropriate to use for estimating Stream C baseline conditions. A mean copper concentration of 2.2 µg/L was measured in the stream (range = <2-4; n = 5).
