**Modern Mine Study:  
Water Quality Performance and Predictions at U.S.  
Mines Permitted Since 1990**

**Prepared by Northeastern Minnesotans for Wilderness  
exclusively for Minnesota State regulatory agencies**

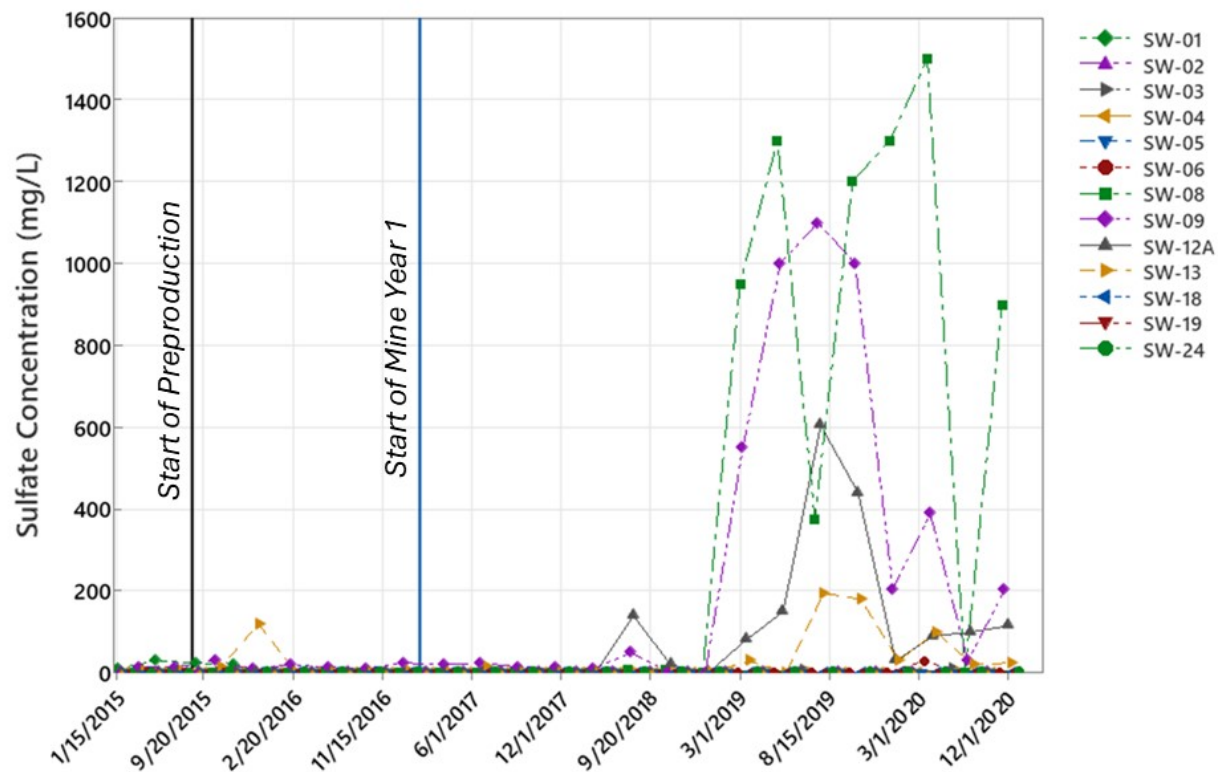
The available sulfate data are particularly sparse. However, the monitoring report for the second half of 2020 includes graphs that illustrate concentration changes over time.<sup>561</sup> In early 2019, sulfate concentrations at SW-08 and SW-09 rose from their 2015 to 2018 averages (of approximately 19 and 27 mg/l respectively) to above 1,000 mg/l, as shown in Figure 4. As of late 2020, sulfate concentrations at SW-08 were above 800 mg/l, and at SW-09 were above 200 mg/l. Sulfate concentrations are also elevated at SW-12A, located immediately downstream of the Haile Gold Mine Creek confluence in Little Lynches River (see Figure 3).

**Haile Figure 4. Sulfate concentrations in surface water monitoring locations, 2015 to 2020.** Monitoring locations are shown in Figure 3. Numeric data were not provided in the NewFields 2021a report. Values were determined visually from Figure E-3 in NewFields (2021a) using horizontal and vertical gridlines; data were entered into Minitab and plotted, and data and graph were also saved as an Excel file. Minor errors in concentrations and dates may exist. *Sources:* NewFields, 2021a. 2020 Second Semi-Annual Groundwater and Surface Water Monitoring Report. *Haile.2020 Second Semiannual.NewFields 2021a.pdf [110].* *HaileGoldMine\_NewFields.Figure.E-3.GraphReproduce\_5Mar2025.xlsx.*

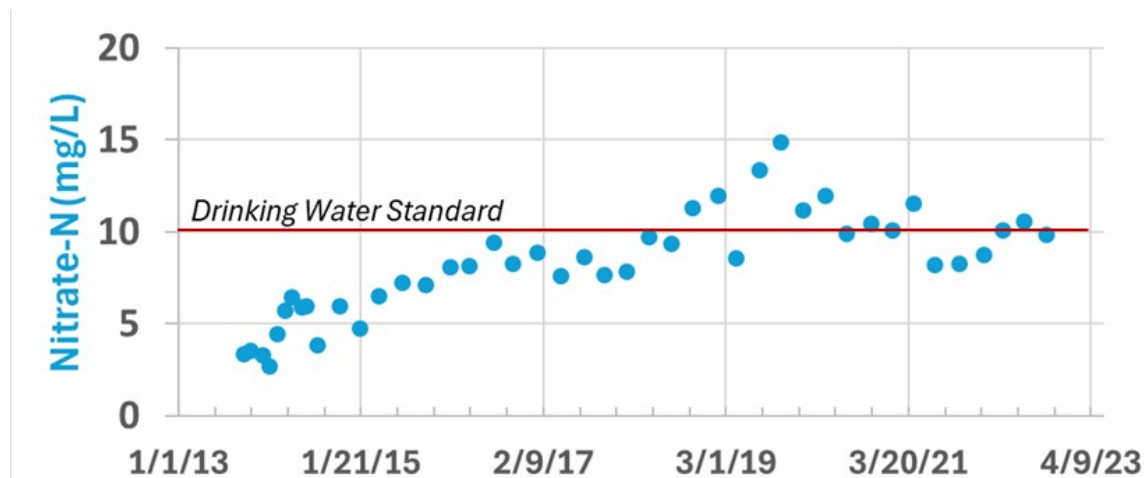
**Kensington Figure 3. Concentrations of nitrate in the tailings pond from 2013 to 2022, compared to the drinking water standard (10 mg/l as N).** Data source: Coeur Alaska, 2022. Kensington Mine Waste Management Permit No. 2013DB0002 4th Quarter 2022 Report, Table 1. *Kensington.2022 4th Quarter.Coeur Alaska 2022.pdf*

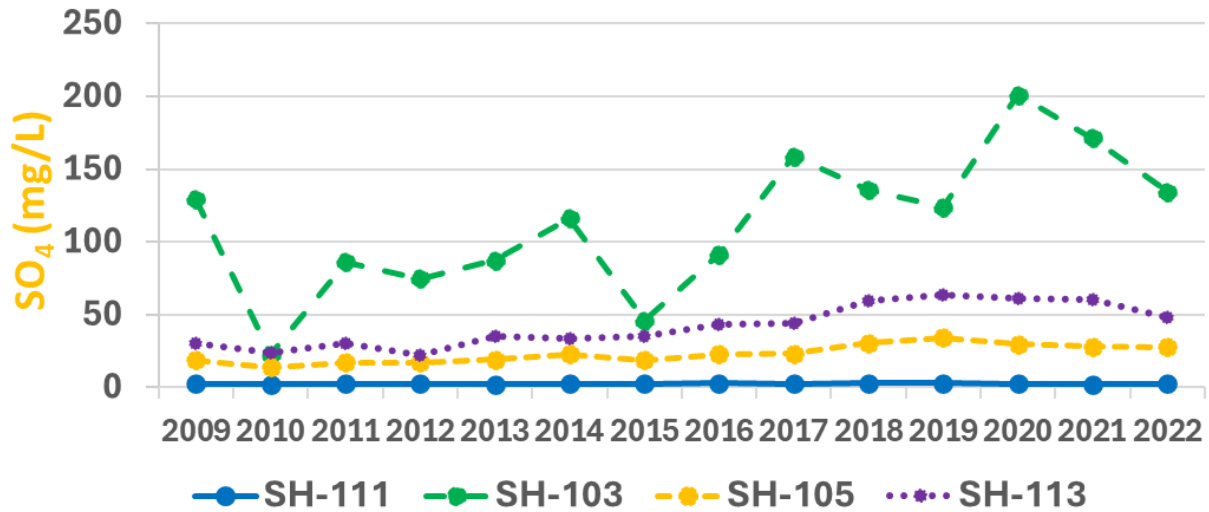
Contributing to the same system, upper Sherman Creek receives discharge from NPDES Outfall 001, which consists of treated mine water mixed with runoff from the waste rock stockpile. Water quality just downstream of the outfall (and upstream of the inflow discussed above from Ophir Creek) shows an approximately threefold increase in TDS (over both baseline and the upstream location), a sixfold increase in sulfate, and a sixteen-fold increase in nitrate.<sup>659</sup>

**Kensington Figure 5a. Mean sulfate concentrations in the Sherman Creek watershed, 2009 to 2022.**

SH-111 is an unimpacted location in Ophir Creek, a tributary of Sherman Creek. *Data source: Kensington annual reports, 2009-2022. See Kensington.Surface water spreadsheet.Feb2025.xlsx*

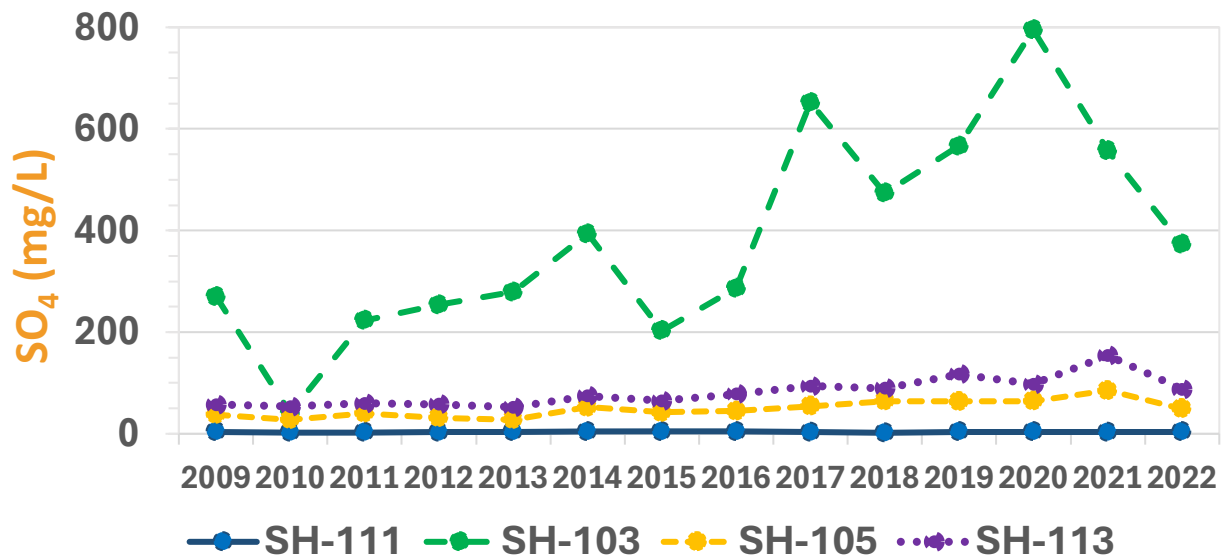
**Kensington Figure 5b. Maximum sulfate concentrations in the Sherman Creek watershed, 2009 to 2022.** SH-111 is an unimpacted location in Ophir Creek, a tributary of Sherman Creek.

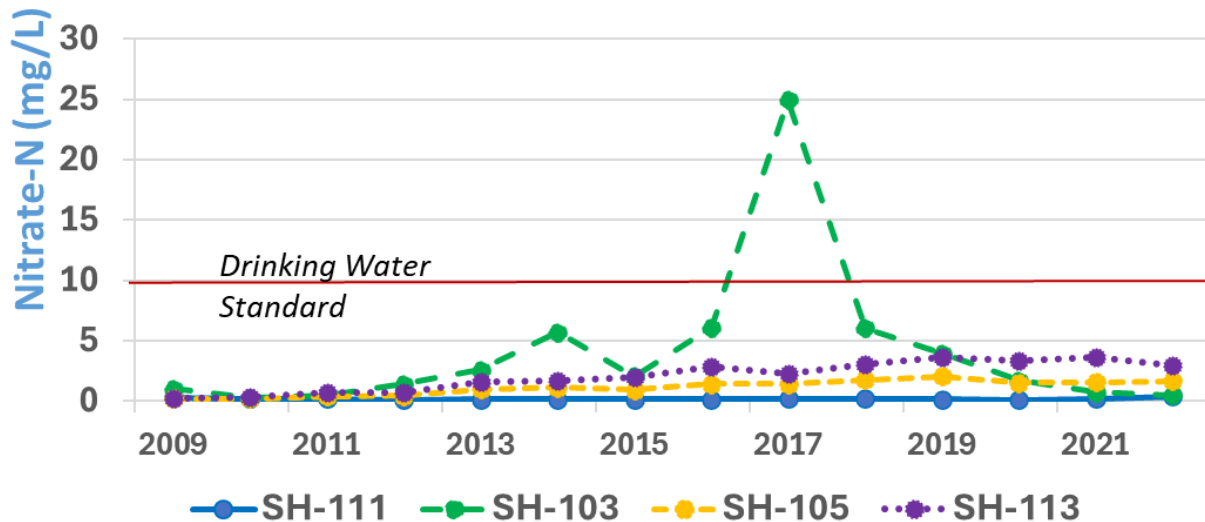
**Kensington Figure 6a. Mean nitrate concentrations in the Sherman Creek watershed, 2009 to 2022, compared to the drinking water standard.** SH-111 is an unimpacted location in Ophir Creek, a tributary of Sherman Creek. *Data source: Kensington annual reports, 2009-2022. See Kensington.Surface water spreadsheet.Feb2025.xlsx*

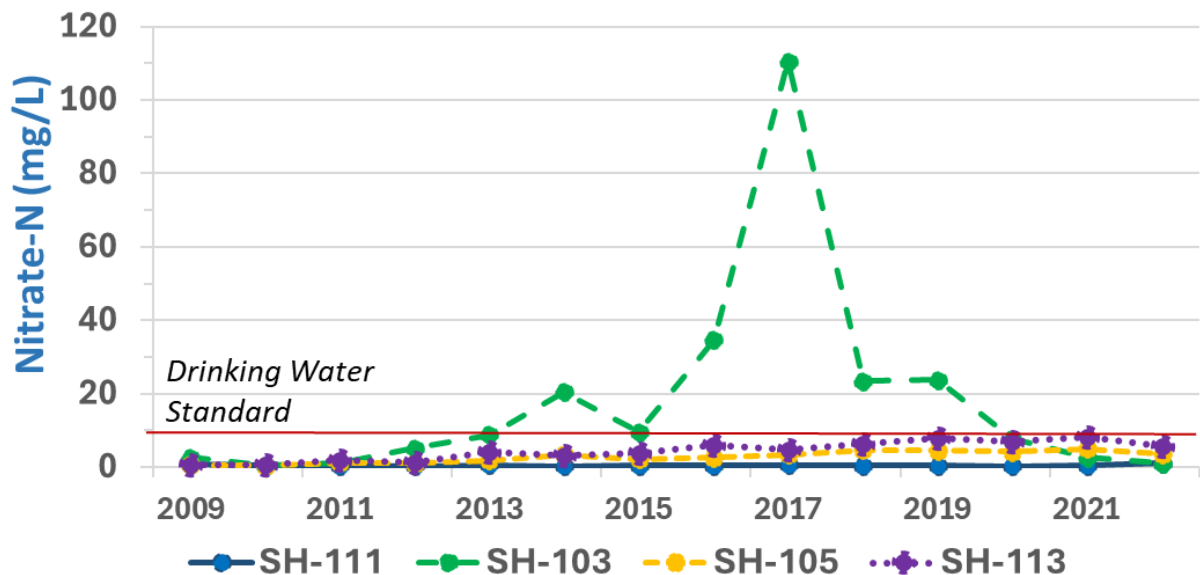
**Kensington Figure 6b. Maximum nitrate concentrations in the Sherman Creek watershed, 2009 to 2022, compared to the drinking water standard.** SH-111 is an unimpacted location in Ophir Creek, a tributary of Sherman Creek. *Data source: Kensington annual reports, 2009-2022. See Kensington.Surface water spreadsheet.Feb2025.xlsx*

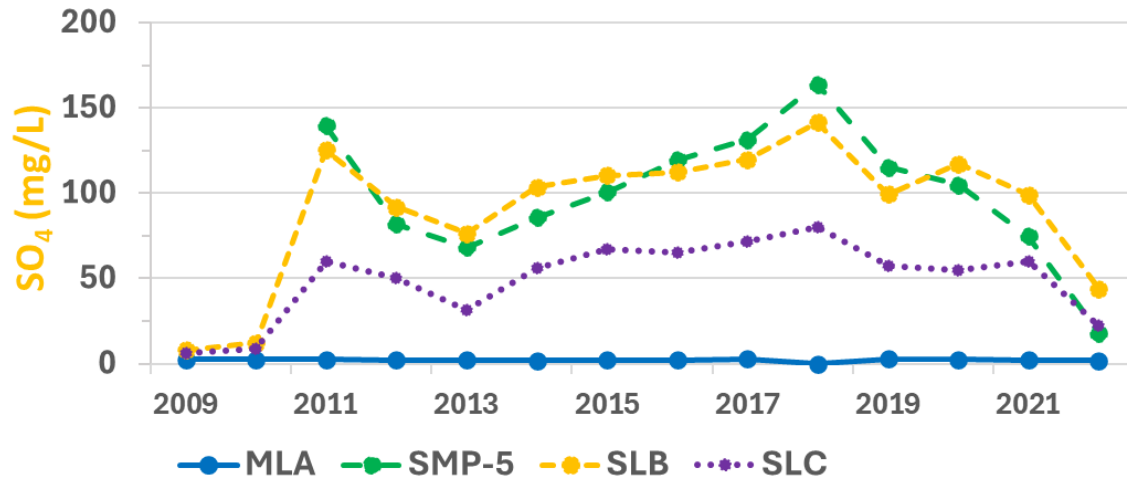
The fourth impacted stream is Slate Creek, where the Kensington tailings impoundment occupies what was formerly Lower Slate Lake. As with Johnson Creek, the EIS provides the range of baseline data but does not reveal the number of monitoring events or average values. The TDS range was 21 to 99 mg/l, the sulfate range was <2 to 4.98 mg/l, and the nitrate range was 0.05 to 0.126 mg/l.<sup>667</sup> Monitoring is done at an unimpacted location upstream of the tailings facility (MLA), just downstream of the treatment plant discharge at Outfall 002 (SMP5), and at two locations further downstream (SLB and SLC) (Figure 7). Sulfate and nitrate concentrations over time at all four monitoring points are shown in Figures 8 and 9.

**Kensington Figure 8a. Mean sulfate concentrations in the Slate Creek watershed.** MLA is an unimpacted location in Upper Slate Creek. *Data source: Kensington annual reports, 2009-2022. See Kensington.Surface water spreadsheet.Feb2025.xlsx.*

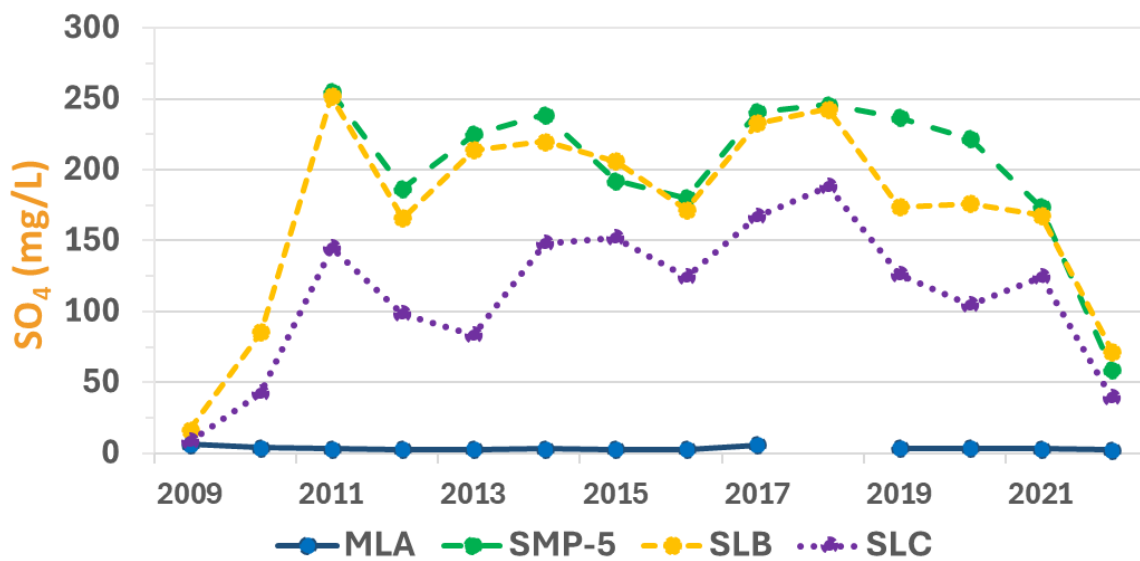
**Kensington Figure 8b. Maximum sulfate concentrations in the Slate Creek watershed.** MLA is an unimpacted location in Upper Slate Creek. *Data source: Kensington annual reports, 2009-2022. See Kensington.Surface water spreadsheet.Feb2025.xlsx.*

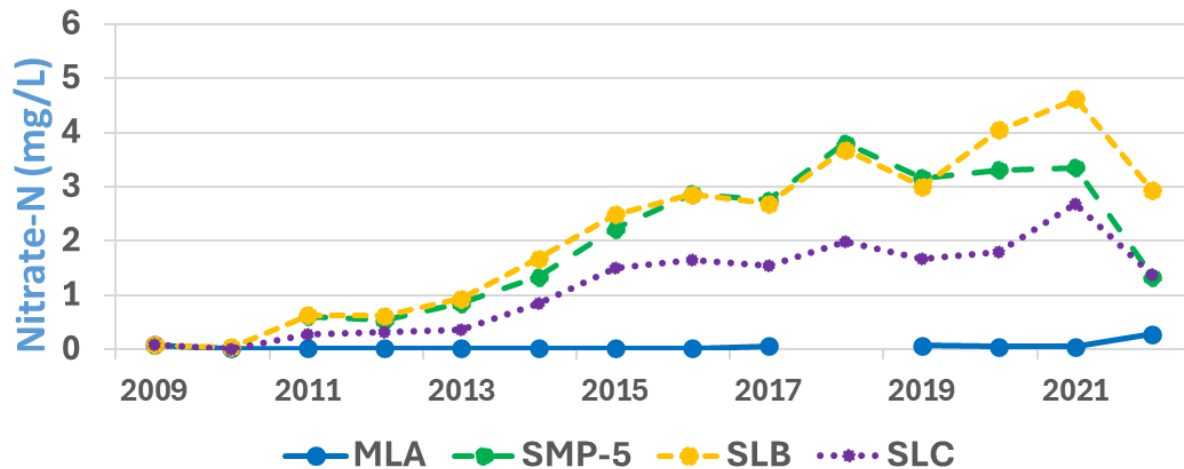
**Kensington Figure 9a. Mean nitrate concentrations in the Slate Creek watershed, 2009 to 2022.**

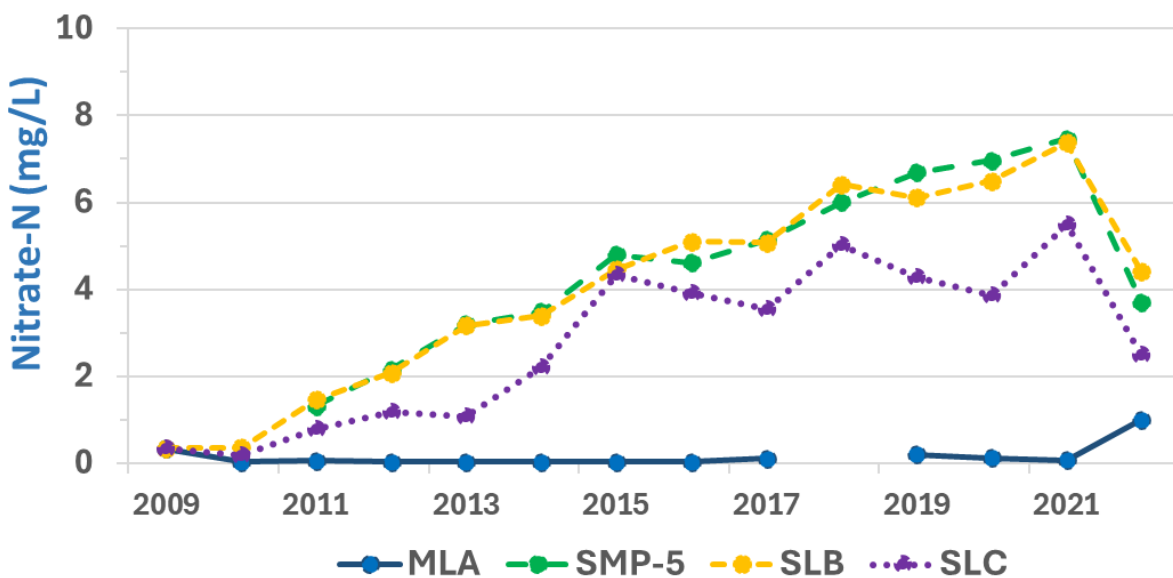
**Kensington Figure 9b. Maximum nitrate concentrations in the Sherman Creek watershed, 2009 to 2022.**

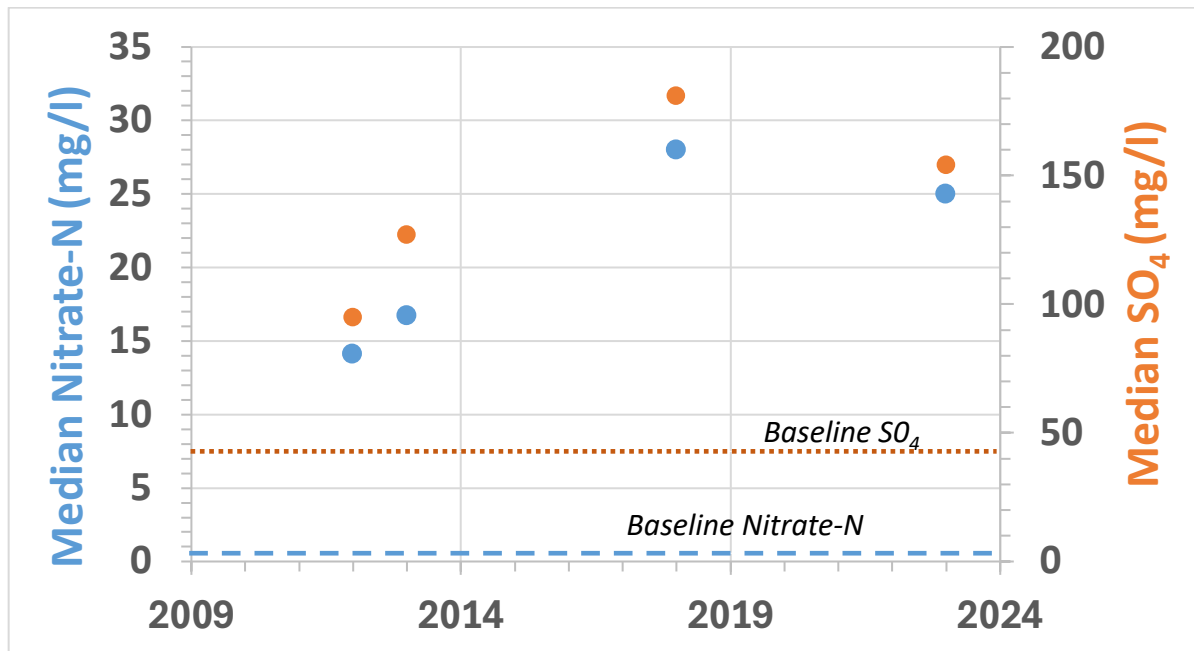
**Pogo Figure 3. Groundwater Sulfate & Nitrate Concentrations, Toe of Dry Stack Tailings Facility (Pogo well MW11-001A).** Baseline values are average concentrations from wells LT-007A, LT-007B, and LT-009. See Table 2 for data sources.

The trend of increasing solute concentration in groundwater over time also appears in wells located farther downgradient from the tailings and waste-rock facility. Specifically, downstream of the Recycle Tailings Pond (RTP) dam, the concentrations of TDS, sulfate, chloride, and nitrate in groundwater consistently increased between 2010 and 2023. The groundwater quality shown in Table 3 and Figure 4 (wells MW3-500 and its replacement, MW12-500) are representative; other wells in the vicinity have similar trends, with concentrations of sulfate and nitrate increasing over time.

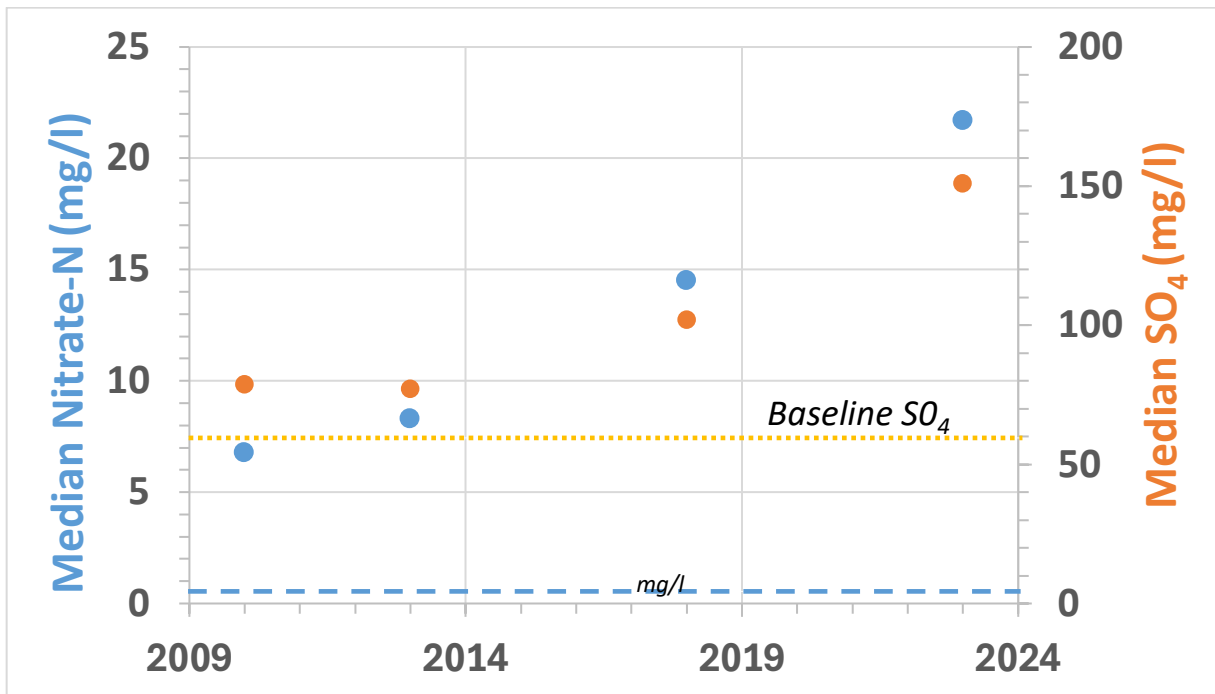
**Pogo Figure 4. Groundwater Sulfate & Nitrate Concentrations, Recycle Tailings Pond Area (Pogo Well MW12-500).** Baseline groundwater concentrations from well LD-005. See Table 3 for data sources.

The RTP is permitted as a zero-discharge facility, with exceedances of designated values in downgradient wells triggering corrective action requirements. The designated values are about twice the baseline measurements: 0.79 mg/l for chloride and 1.28 mg/l as N for nitrate.<sup>744</sup> The corrective action triggers are and have been routinely exceeded for at least fourteen years. The nitrate water quality standard of 10 mg/l as N is also often exceeded. According to the 2022 Annual Report, containment of dam seepage is being evaluated in a "corrective action investigation."<sup>745</sup> It is unclear what corrective action is being considered.

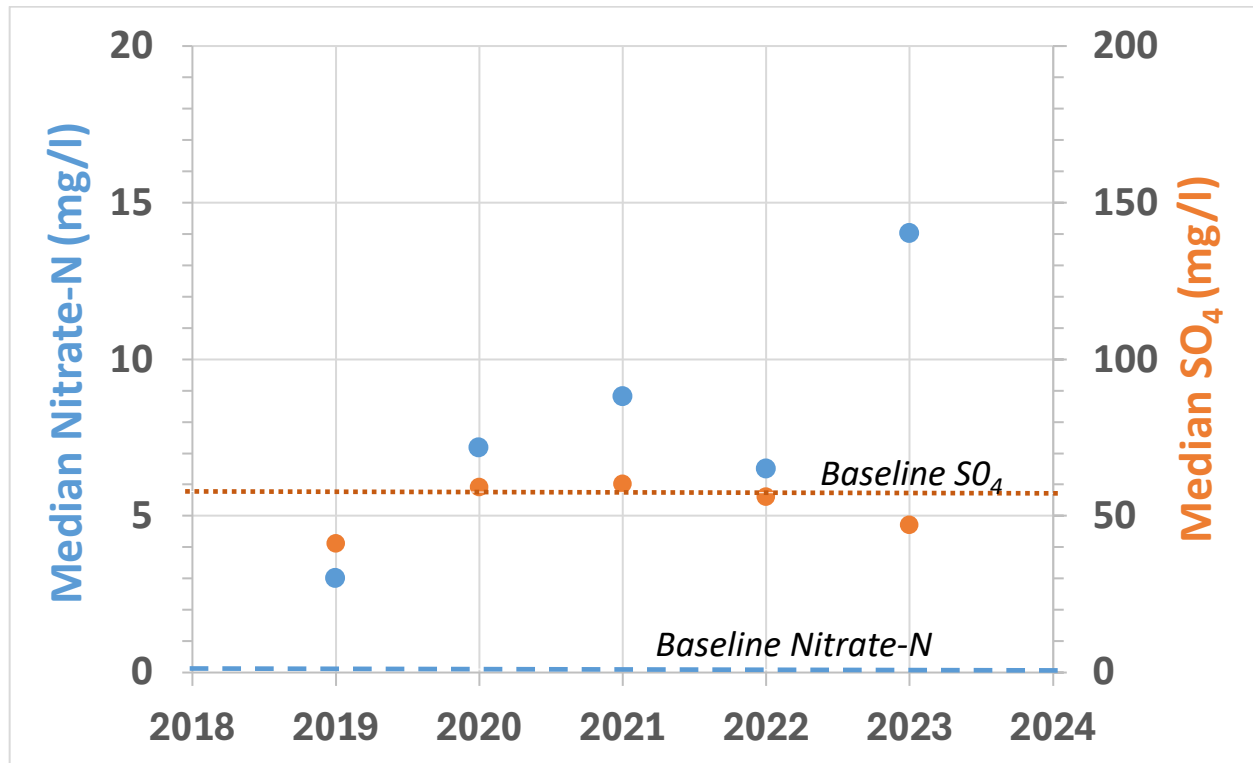
to 14 mg/l as N in 2023 (Figure 5). At this distance from the tailings, there appears to be some differential migration of solutes, with the very mobile nitrate arriving more quickly than sulfate. Maximum nitrate concentrations in groundwater have been above the 10 mg/l as N standard every year since 2020.

**Pogo Figure 5. Groundwater Sulfate & Nitrate, near Liese Creek and Goodpastor R. (Pogo well MW13-003A).** Baseline concentrations are from well MW04-213. Data sources: Northern Star Resources, Ltd., 2021. 2020 Annual Monitoring Report, Appendix F. *Pogo.2020 Annual Report App F.Northern Star 2021.xlsx*; Northern Star Resources, Ltd., 2022. 2021 Annual Monitoring Report, Appendix F. *Pogo.2021 Annual Report App F.Northern Star 2022.xlsx*; Northern Star Resources, Ltd., 2023. 2022 Annual Monitoring Report, Appendix F. *Pogo.2022 Annual Report App F.Northern Star 2023.xlsx*; Northern Star Resources, Ltd., 2024. 2023 Annual Monitoring Report, Appendix E. *Pogo.2023 Annual Report App E.Northern Star 2024.xlsx*

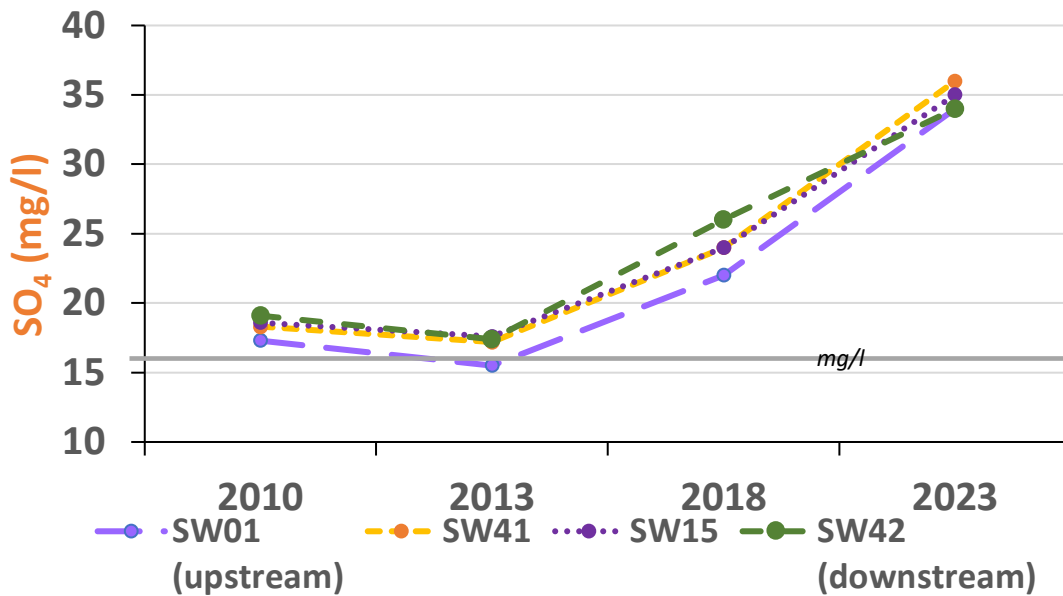
**Pogo Figure 6. Surface-Water Sulfate Concentrations in the Goodpastor River.** See Table 4 for data sources.

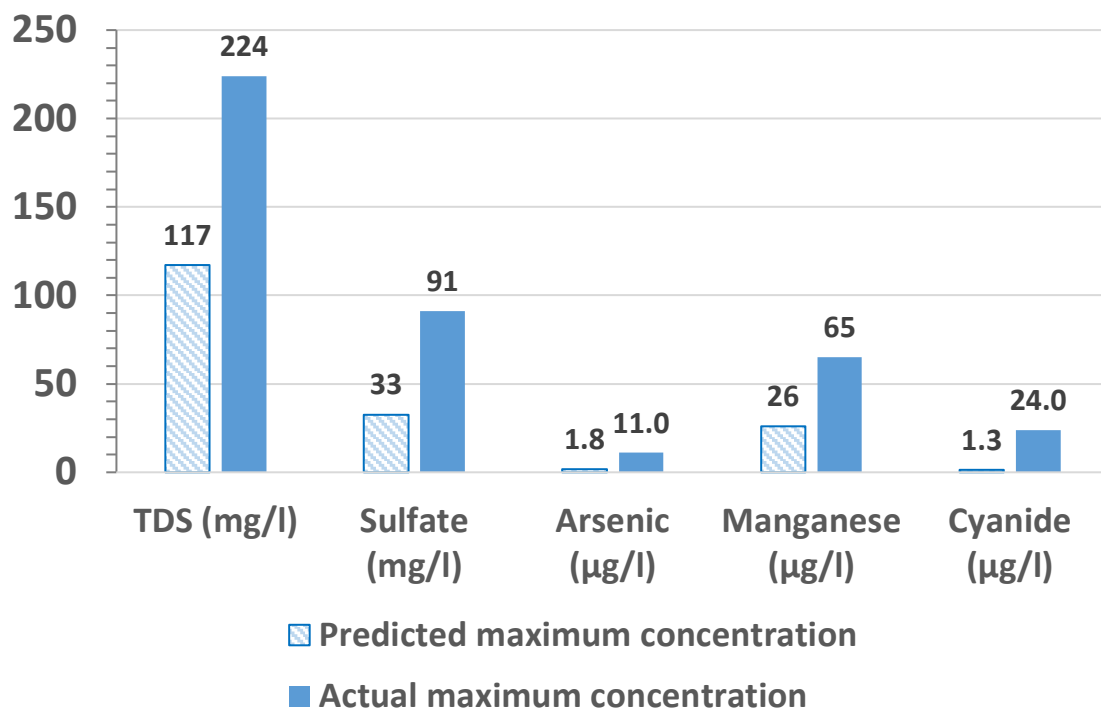
The EIS also provided predictions of the quality of effluent after mixing with river water (Outfall 001), which were generally accurate in terms of average concentrations. An exception is TDS, which was predicted to average 113 mg/l but averaged 140 mg/l in the 2010 to 2019 time period. However, predictions of maximum concentrations were lower than measured maxima for several pollutants (Table 6 and Figure 7).

**Pogo Figure 7. Predicted vs. Actual Maximum Concentrations in Treatment Plant Outfall 001.**
